Historic Preservation Commission Agenda

LOCAL HISTORIC PROPERTY DESIGNATION REPORT

Washington-Evergreen Historic District

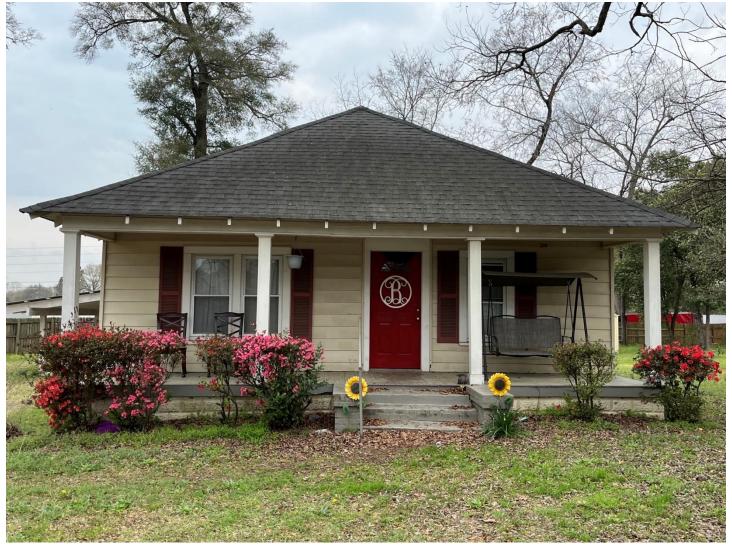
- 1. Unknown
- 2. 1920
- 3. –
- 4. Craftsman
- 5. Craftsman character, exposed rafter tails, contributes to neighborhood development pattern.
- 6. Vinyl siding, vinyl replacement windows, rear addition, carport addition on left side.

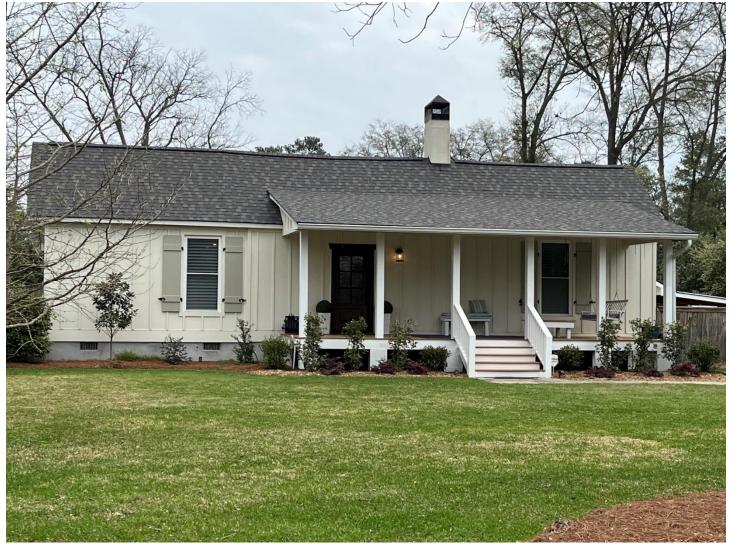
- 1. Unknown
- 2. 1913
- 3. –
- 4. No Academic Style
- 5. Contributes to neighborhood development pattern.
- 6. New cementitious siding, vinyl replacement windows, reconstructed front porch, rear addition, 2 detached garages.

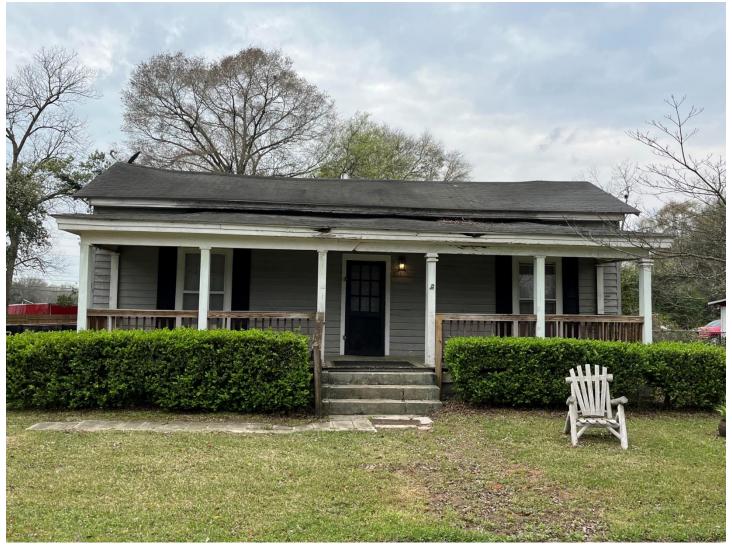
- 1. Unknown
- 2. 1920
- 3. –
- 4. No Academic Style
- 5. Original wood siding, original windows, contributes to neighborhood development pattern.
- 6. Porch railing added.

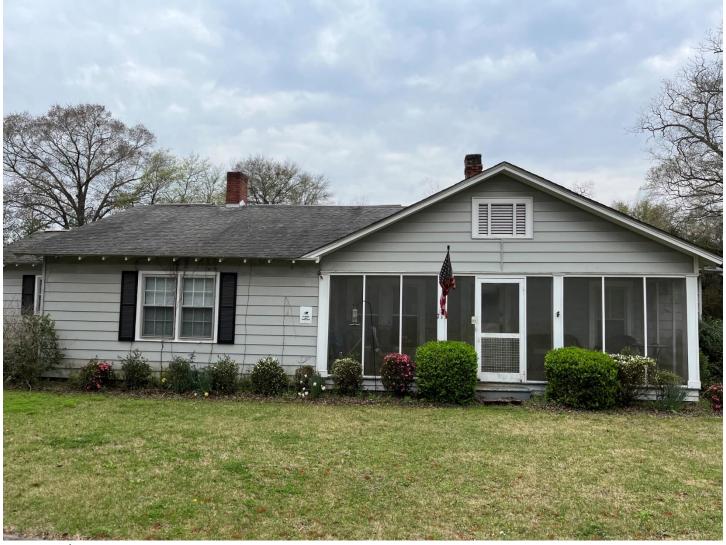
- 1. Unknown
- 2. 1925
- 3. –
- 4. Craftsman
- 5. Contributes to neighborhood development pattern.
- 6. Aluminum siding, vinyl replacement windows, addition on left side and rear (garage), 3 detached outbuildings.

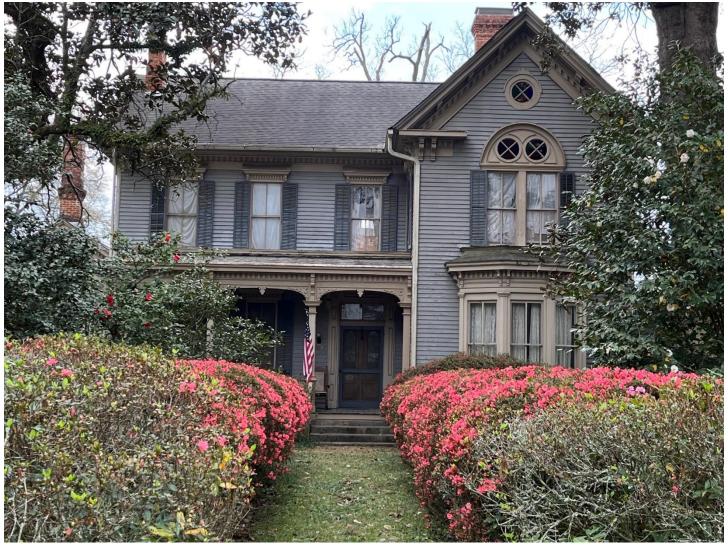
- 1. Judge Clinton C. Duncan House
- 2. 1835
- 3. Second story addition in 1877
- 4. Folk Victorian
- 5. Original exterior materials, windows, details.
- 6. Addition and renovations on rear, detached carport added in 1983.

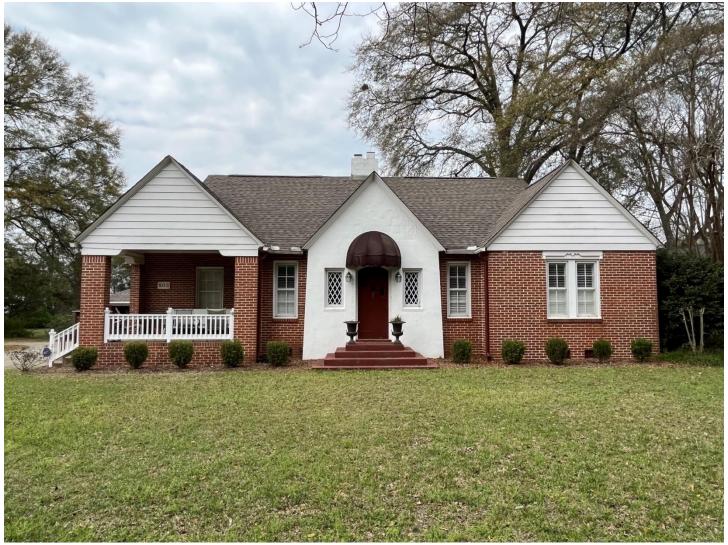
- 1. Charles Harris House
- 2. 1930
- 3. –
- 4. English Vernacular Revival
- 5. Original windows, contributes to neighborhood development pattern.
- 6. Aluminum siding on gables, detached carport.

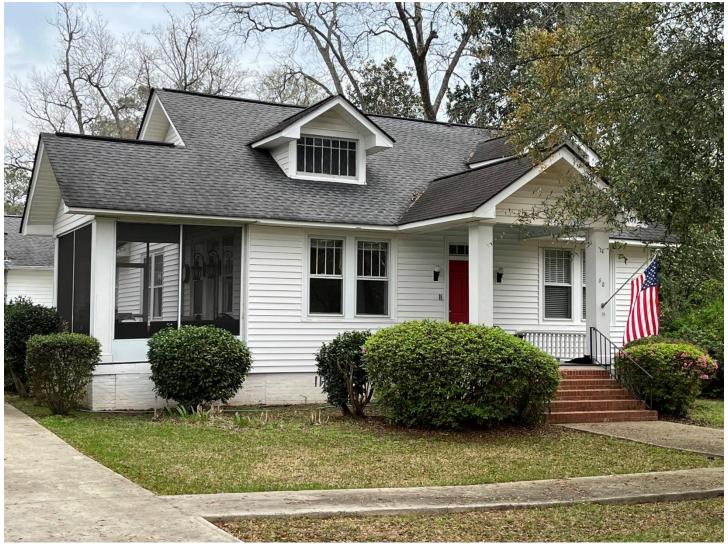
- 1. Unknown
- 2. 1925
- 3.
- 4. Craftsman
- 5. Original windows, contributes to neighborhood development pattern.
- 6. Vinyl siding, rear addition, screened side porch, detached outbuilding.

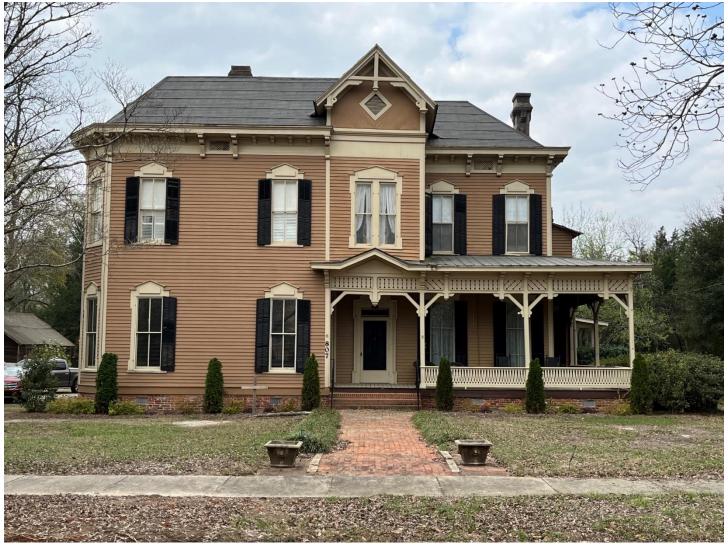
- 1. Charles & Cinderella Cooper House
- 2. 1880
- 3. Outbuilding believed to be original stables (next page
- 4. American Queen Anne/Stick
- 5. Original siding, windows, details, contributes to neighborhood development pattern.
- 6. Addition to rear, 2 detached outbuildings (including original stable).

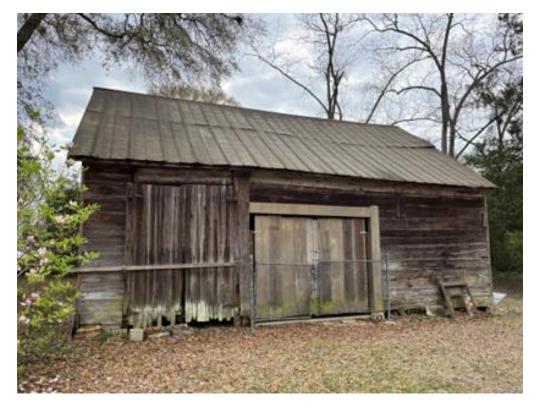
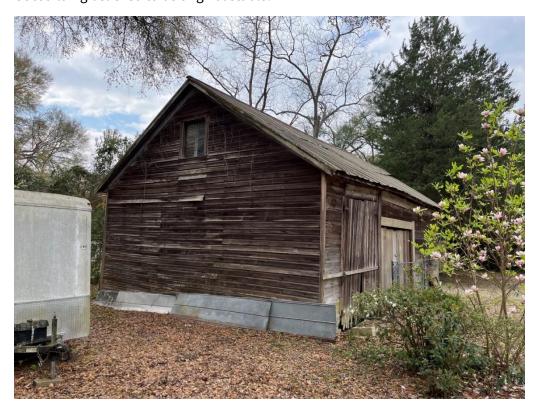
807 Washington Street Secondary Structure 0P0040 052000

Outbuilding believed to be original stable.

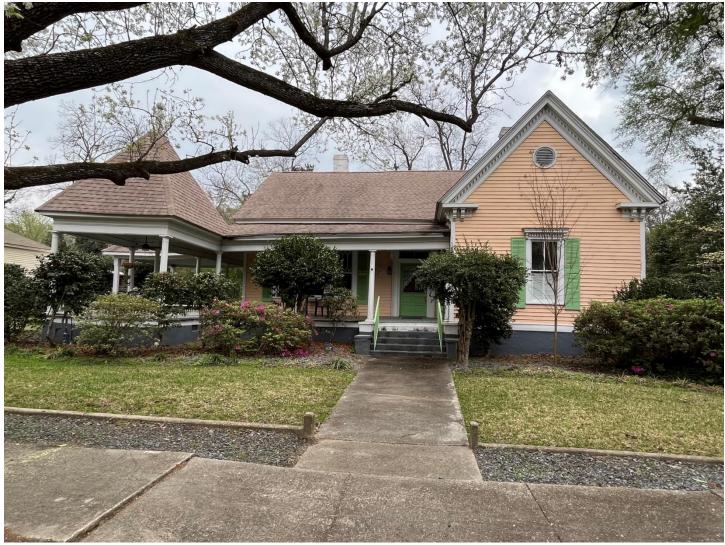
- 1. Cater-Jones-Ayers House
- 2. 1875
- 3. -
- 4. Folk Victorian
- 5. Original siding, windows, contributes to neighborhood development pattern.
- 6. Addition on rear, detached outbuilding.

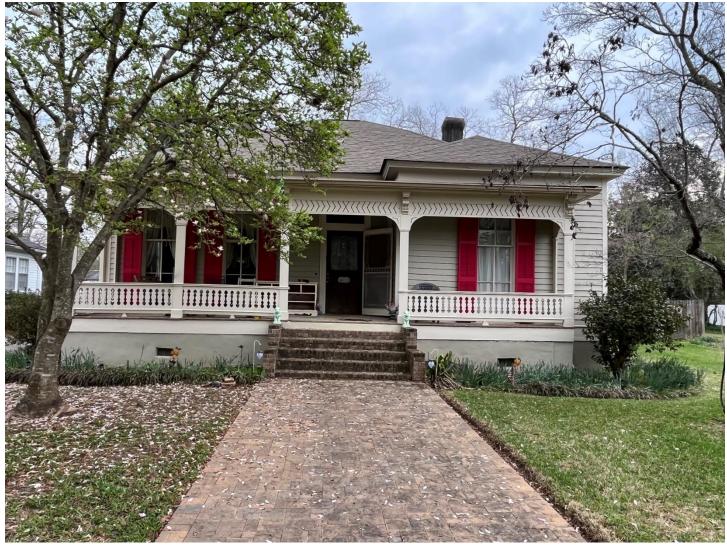
- 1. Miller-Norwood House
- 2. 1854
- 3. --
- 4. American Queen Anne
- 5. Original siding, windows, details, contributes to neighborhood development pattern.
- 6. Addition on rear.

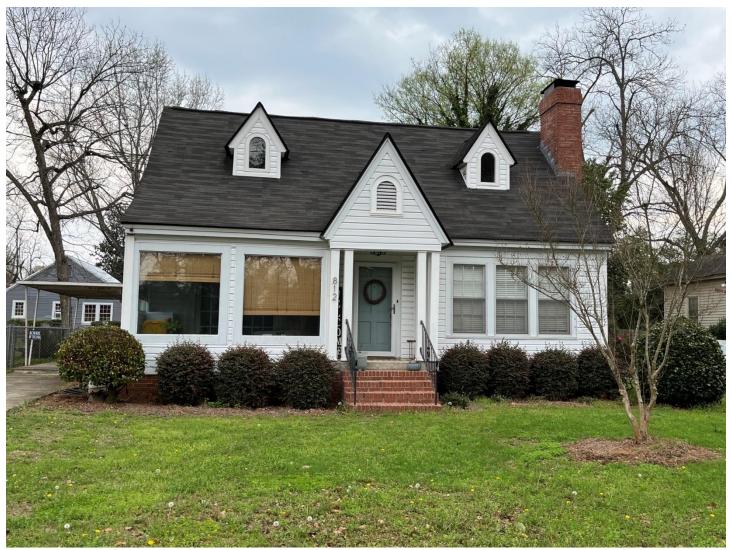
812 Washington Street 0P0030 020000

- 1. Unknown
- 2. 1940
- 3.
- 4. English Vernacular Revival/Colonial Revival
- 5. Original windows, Contributes to neighborhood development pattern.
- 6. Vinyl siding, enclosed front porch, replacement windows in dormers, rear addition, detached aluminum carport, detached outbuilding.

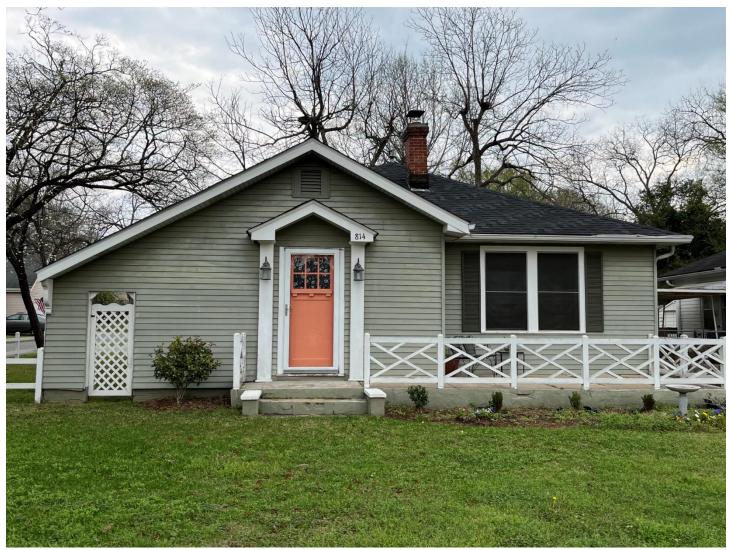
- 1. Annie Meadows House
- 2. 1942
- 3. –
- 4. No Academic Style
- 5. Contributes to neighborhood development pattern.
- 6. Vinyl siding, replacement windows, porch railing, rear addition.

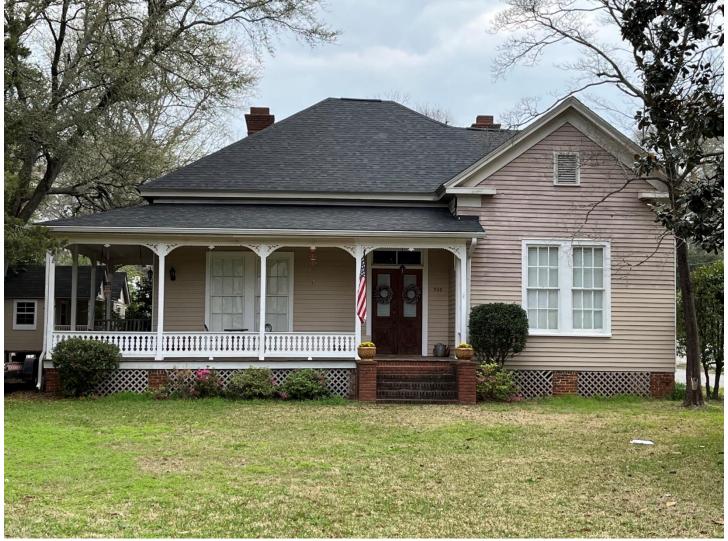
- 1. J. G. Vissher House
- 2. 1855
- 3. –
- 4. American Queen Anne
- 5. Original siding, windows, details, contributes to neighborhood development pattern.
- 6. Rear addition with attached garage.

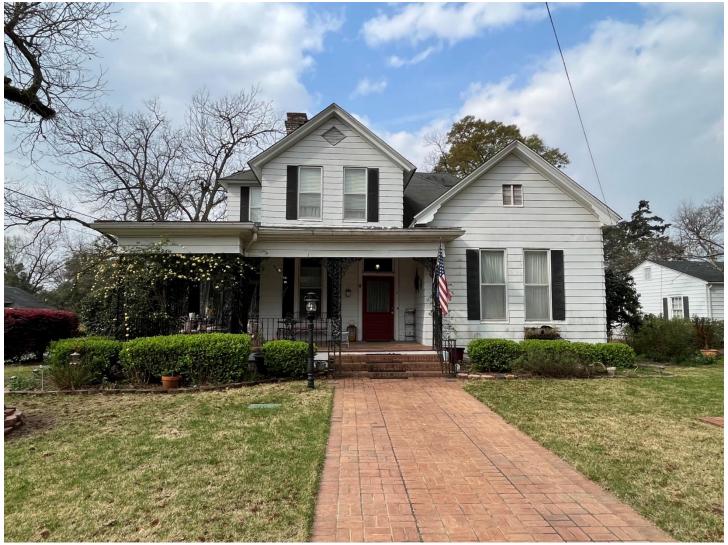
- 1. Perry Methodist Church Parsonage-Norwood House
- 2. 1915
- 3. –
- 4. No Academic Style
- 5. Contributes to neighborhood development pattern.
- 6. Aluminum siding, aluminum replacement windows, wrought iron porch columns and railing, detached garage built in 1961.

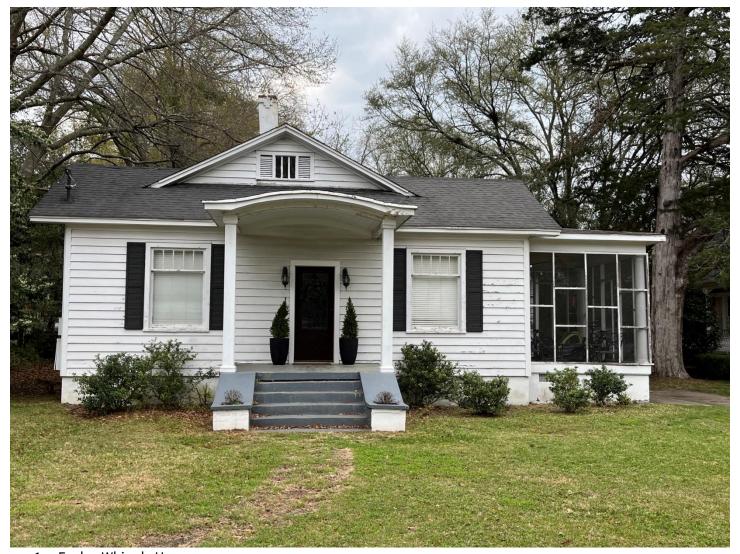
- 1. Evelyn Whipple House
- 2. 1927
- 3. -
- 4. Colonial Revival
- 5. Original siding, windows, contributes to neighborhood development pattern.
- 6. Rear addition 2020.

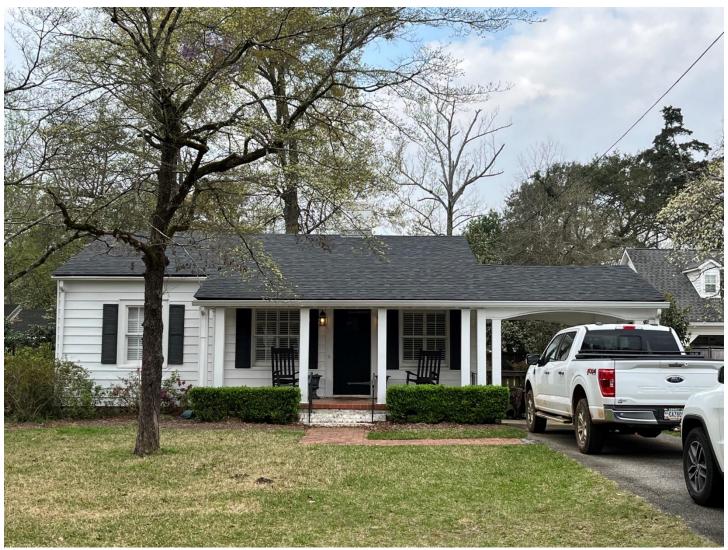
903 Washington Street 0P0040 037000

- 1. Evans House
- 2. 1941
- 3. -
- 4. Colonial Revival
- 5. Contributes to neighborhood development pattern.
- 6. Vinyl siding, windows, replaced porch columns.

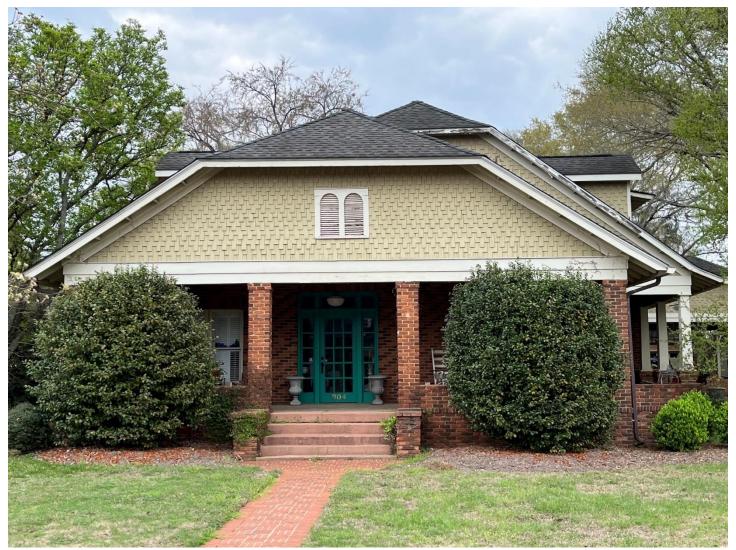
- 1. Lucille Kezar Cooper House
- 2. c. 1920
- 3. Perry's first brick house
- 4. Craftsman
- 5. Original brick and shingle gables, detached garage 1920, contributes to neighborhood development pattern.
- 6. Replacement windows, dormers added to sides, detached carport.

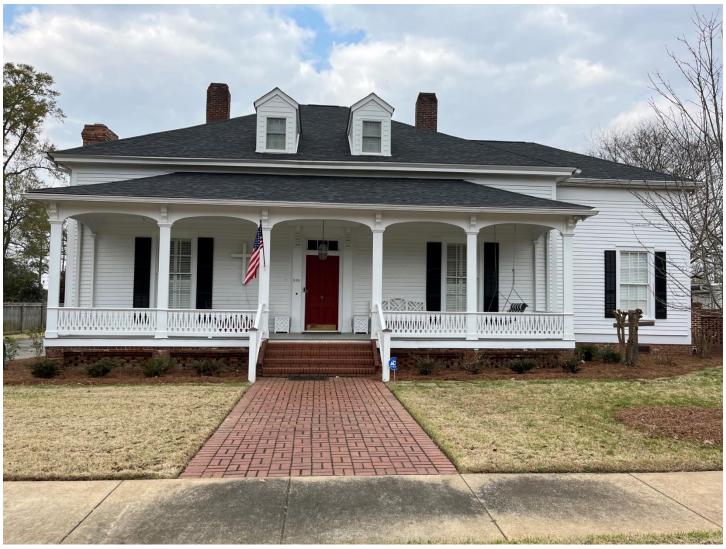
905 Washington Street 0P0040 038000

- 1. Rogers House
- 2. 1880
- 3.
- 4. Carpenter Italianate
- 5. Original siding and details, contributes to neighborhood development pattern.
- 6. Replacement windows, additions on right side and rear.

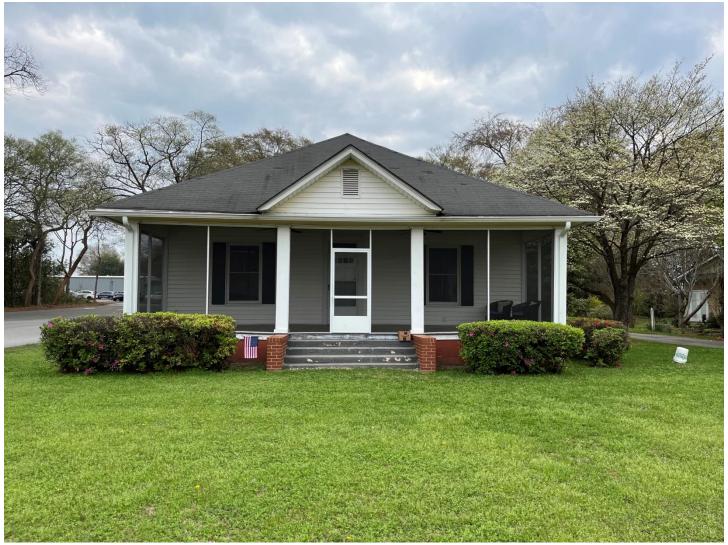
906 Washington Street 0P0030 003000

- 1. Unknown
- 2. 1920
- 3. –
- 4. No Academic Style
- 5. Contributes to neighborhood development pattern.
- 6. Vinyl siding and windows, rear addition, attached garage.

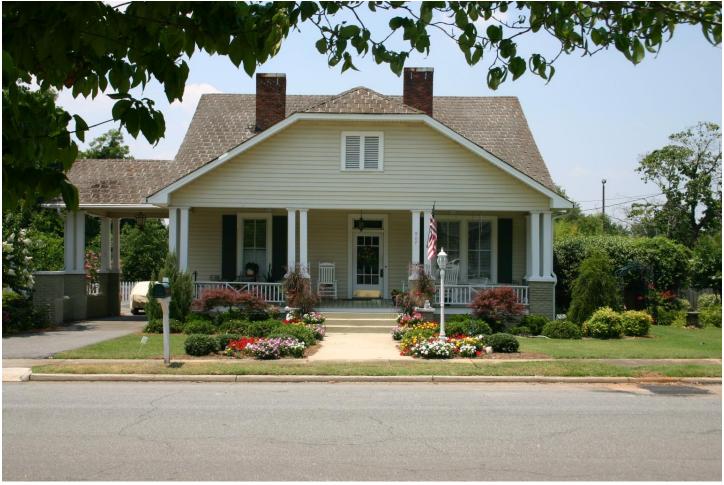
907 Washington Street 0P0040 039000

- 1. H. P. Houser House
- 2. 1890
- 3. –
- 4. Craftsman
- 5. Contributes to neighborhood development pattern.6. Vinyl siding, windows, rear addition, 2 detached outbuildings.

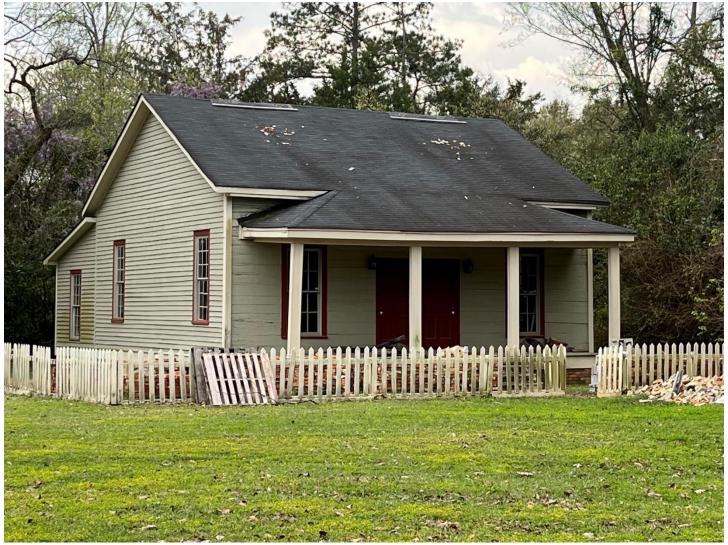
- 1. Hoton-Skellie-Houser House
- 2. 1850
- 3. Moved from Evergreen Street in 1986
- 4. No Academic Style
- 5. Original siding and windows.
- 6. None

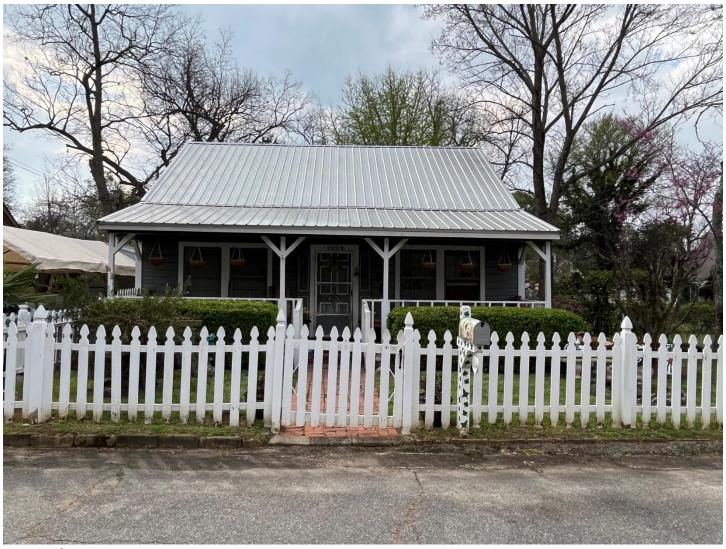
- 1. Irby House
- 2. 1944
- 3. –
- 4. No Academic Style
- 5. Original siding, contributes to neighborhood development pattern.
- 6. Metal roof 2017.

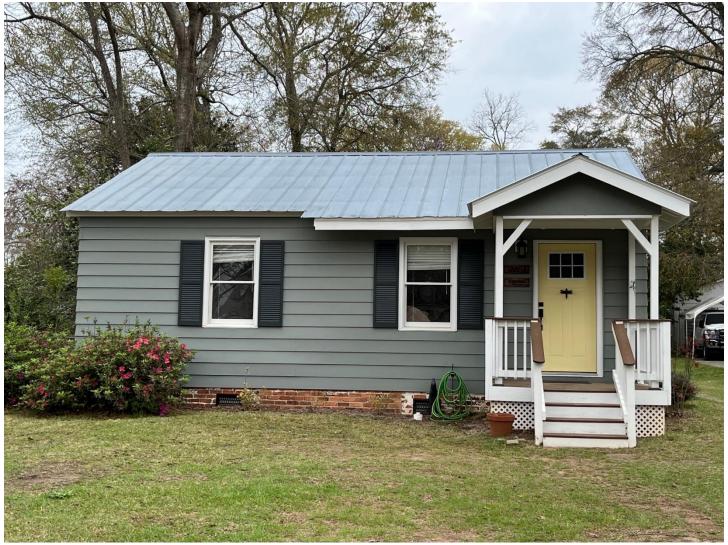
- 1. Herndon House
- 2. 1949
- 3. –
- 4. No Academic Style
- 5. Original siding, contributes to neighborhood development pattern.
- 6. Replacement windows, metal roof, front porch deck.

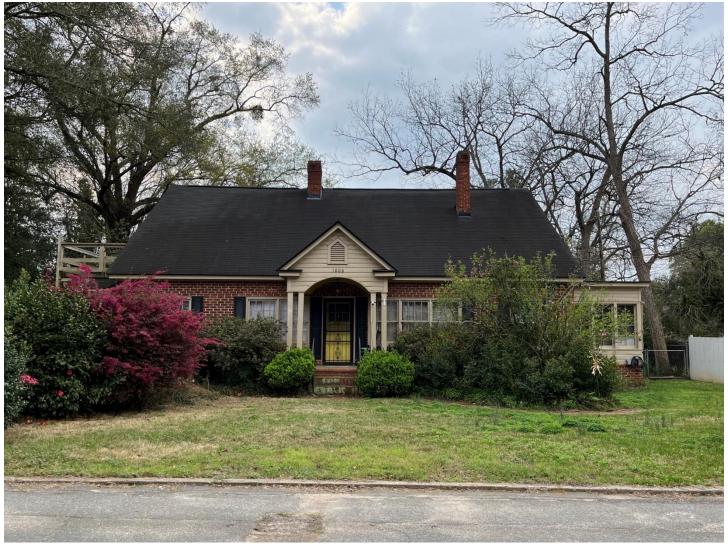
- 1. Unknown
- 2. 1940
- 3.
- 4. Colonial Revival
- 5. Original brick, windows, contributes to neighborhood development pattern.
- 6. Stairs/deck on left side access to upper floor, possible right wing addition, detached outbuilding.

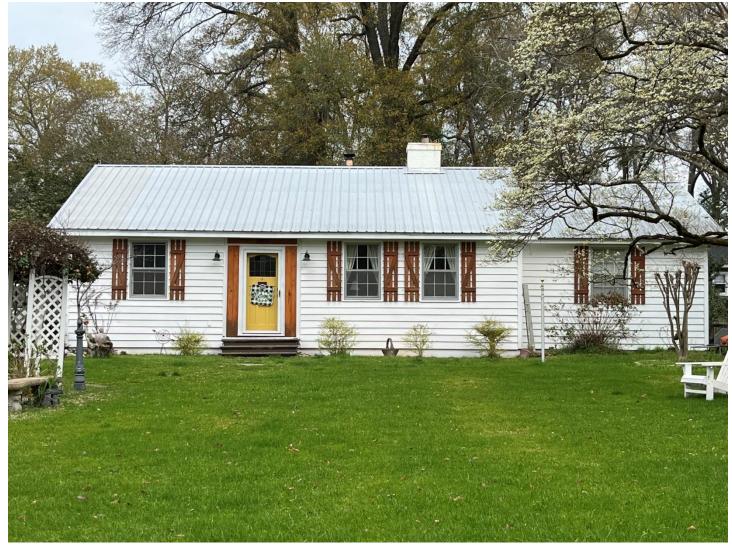
- 1. O'Neal House
- 2. 1959
- 3.
- 4. Minimal Traditional
- 5. Contributes to neighborhood development pattern.
- 6. Vinyl siding, windows, right side and rear additions, detached outbuilding.

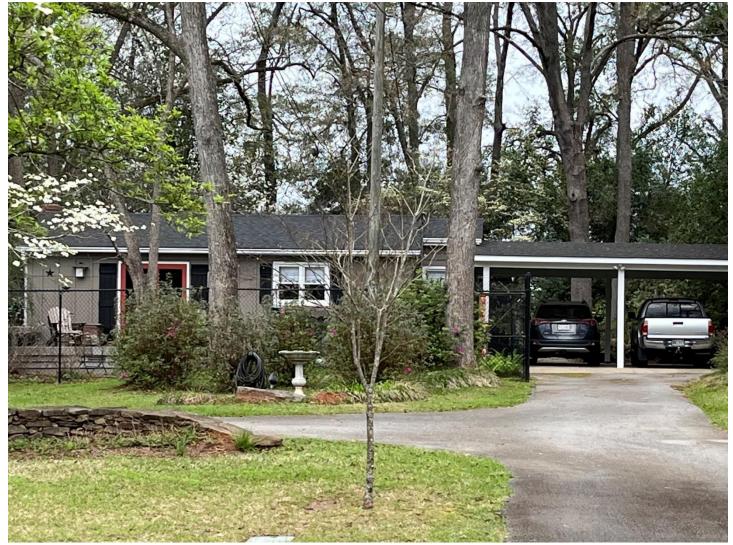
- 1. Kate Houser House
- 2. 1952
- 3. –
- 4. No Academic Style
- 5. Contributes to neighborhood development pattern.
- 6. Vinyl replacement windows, carport addition.

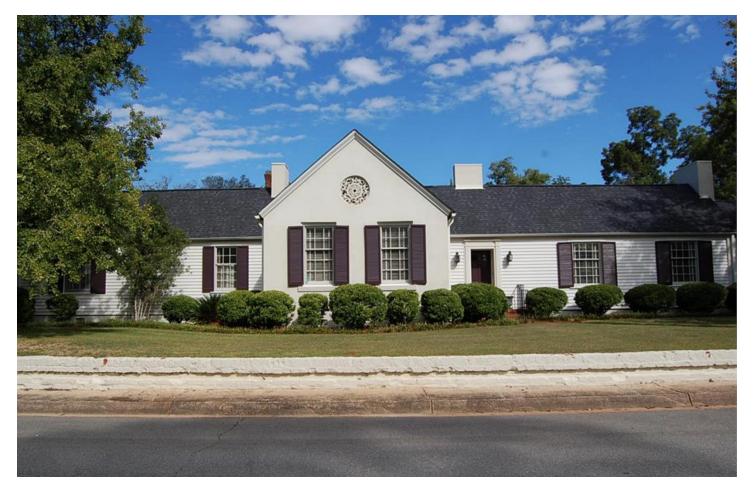
- 1. Pritchett House
- 2. 1935
- 3. –
- 4. Colonial Revival
- 5. Contributes to neighborhood development pattern.
- 6. Vinyl siding, windows, rear addition.

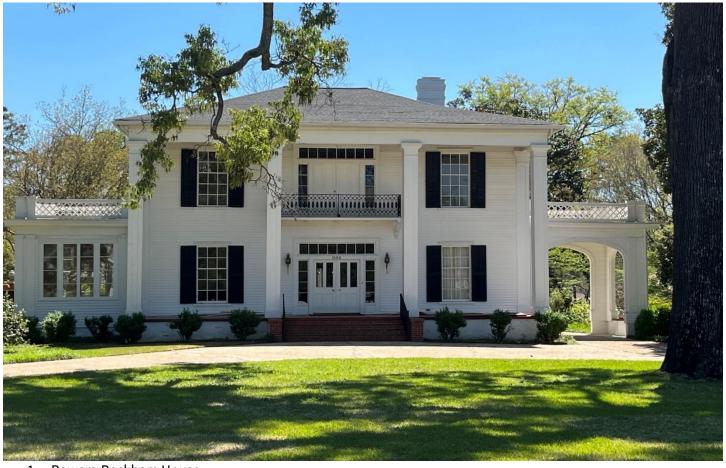
- 1. Powers-Beckham House
- 2. 1870
- 3. Moved from Main Street to current location in 1924, sunporch and Porte cochere added in 1924.
- 4. Greek Revival/Neoclassical Revival
- 5. Original siding, porch, entry, balcony, contributes to neighborhood development pattern.
- 6. Replacement windows, rear addition.

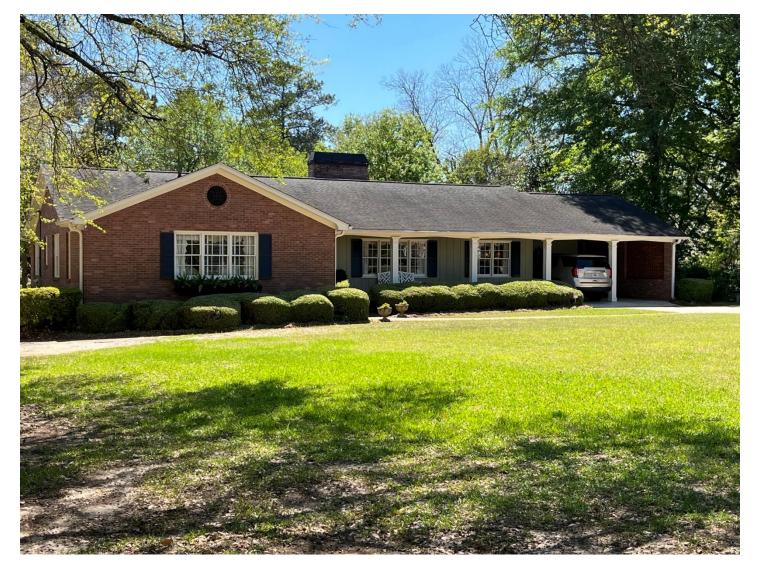
- 1. Beckham House
- 2. 1960
- 3. –
- 4. Minimal Traditional
- $5. \quad \text{Original brick and wood siding, contributes to neighborhood development pattern.} \\$
- 6. Vinyl replacement windows.

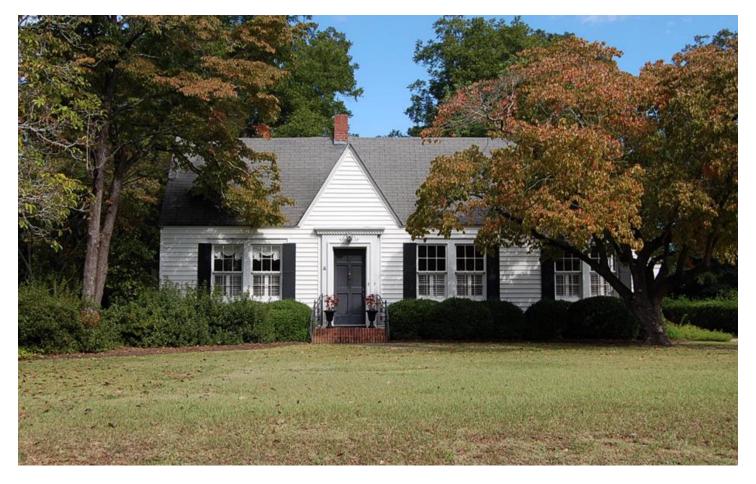
- 1. S. A. Nunn House
- 2. 1937
- 3. Childhood home of former U. S. Senator Sam Nunn.
- 4. English Vernacular Revival/Colonial Revival/Minimal Traditional
- 5. Original windows, contributes to neighborhood development pattern.
- 6. Vinyl siding, rear addition, attached carport.

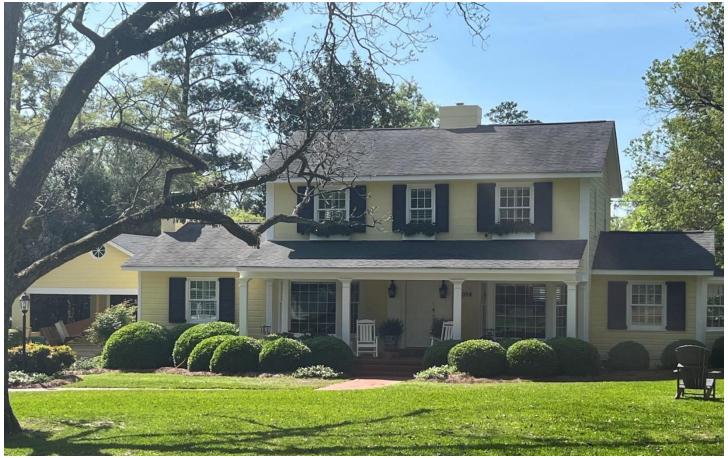
- 1. Lewis House
- 2. 1950
- 3. –
- 4. Colonial Revival
- 5. Original siding, contributes to neighborhood development pattern.
- 6. Replacement windows, rear addition, semi-attached carport, possible wing additions.

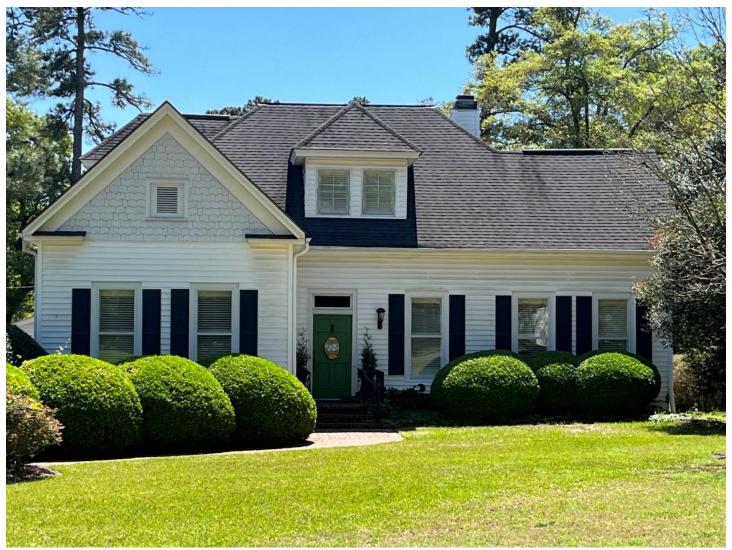
- 1. Chapman-Mitchell House
- 2. 1900
- 3. Moved from Main Street in the 1960s
- 4. American Queen Anne
- 5. Contributes to neighborhood development pattern.
- 6. Vinyl siding, replacement windows, rear addition, attached garage, covered front porch removed during move.

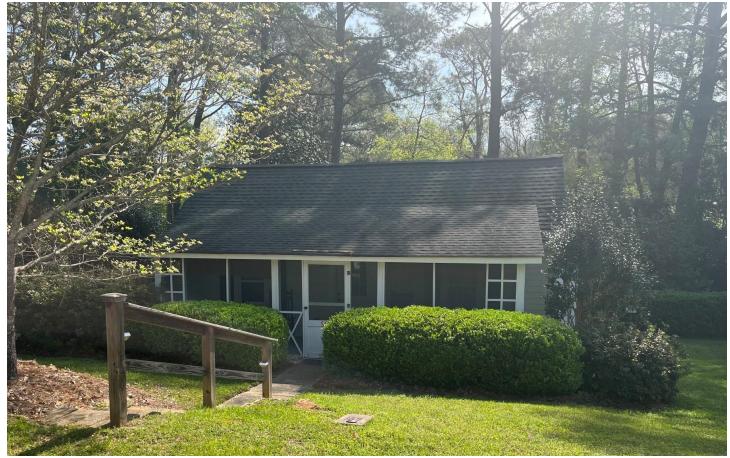
- 1. Unknown
- 2. 1925
- 3. –
- 4. No Academic Style
- 5. Original wood siding, contributes to neighborhood development pattern.
- 6. Vinyl replacement windows.

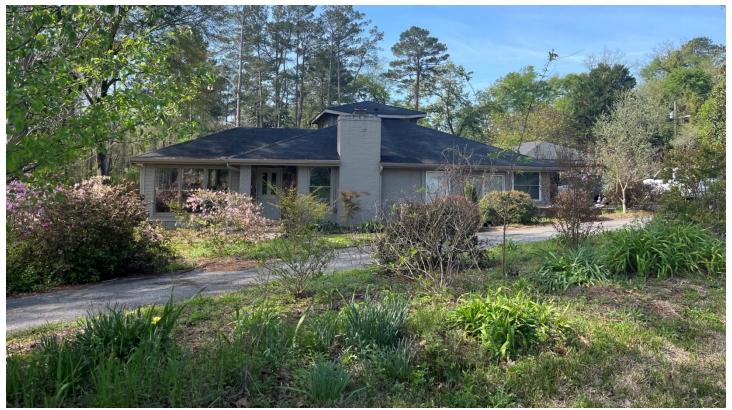
909 Massee Lane 0P0100 007000

- 1. Mann House
- 2. 1954
- 3. –
- 4. No Academic Style
- 5. Contributes to neighborhood development pattern.
- 6. Additions, semi-attached carport, 2 detached outbuildings.

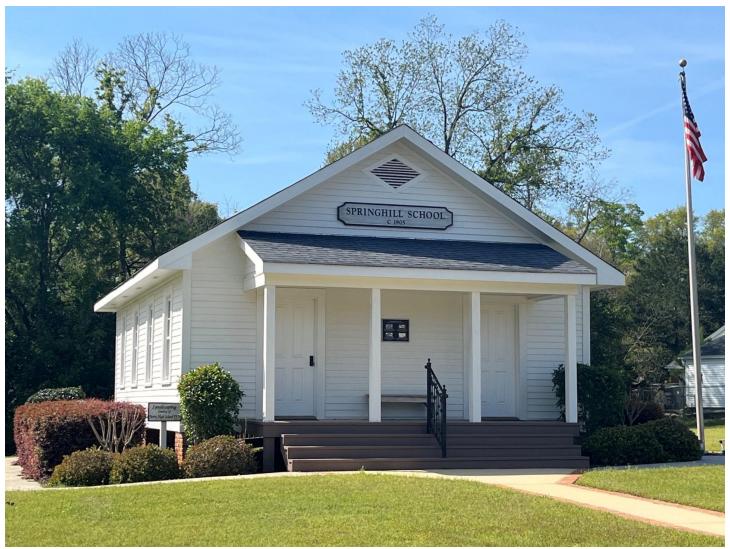
- 1. Springhill School
- 2. 1905
- 3. Old schoolhouse moved to current location and restored.
- 4. No Academic Style
- 5. Represents early 20th Century educational buildings.
- 6. None

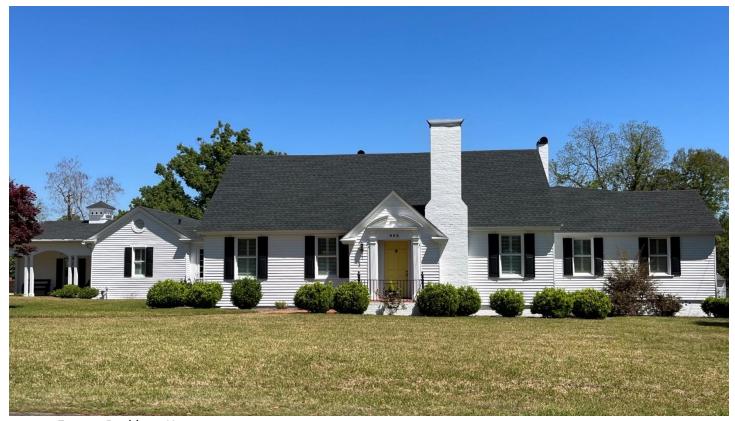
- 1. Eugene Beckham House
- 2. 1929
- 3. Original four-room house
- 4. Colonial Revival/Minimal Traditional
- 5. Contributes to neighborhood development pattern.
- 6. Vinyl siding, replacement windows, additions to sides and rear, attached carport.

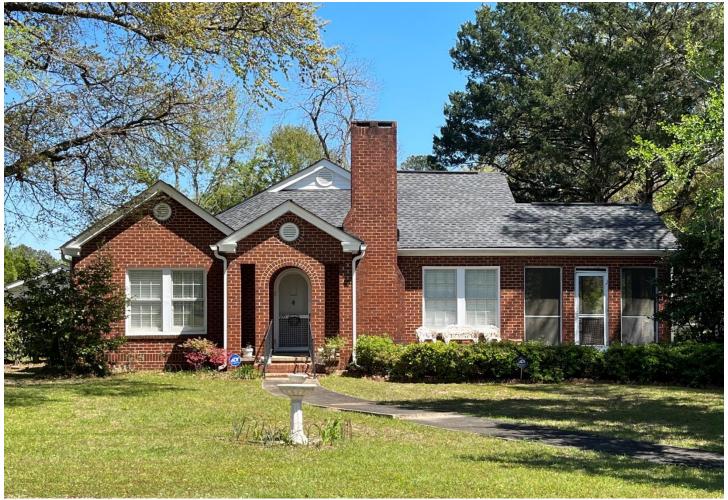
- 1. Unknown
- 2. 1940
- 3. –
- 4. English Vernacular Revival
- 5. Original materials, windows, front door.
- 6. Detached outbuilding.

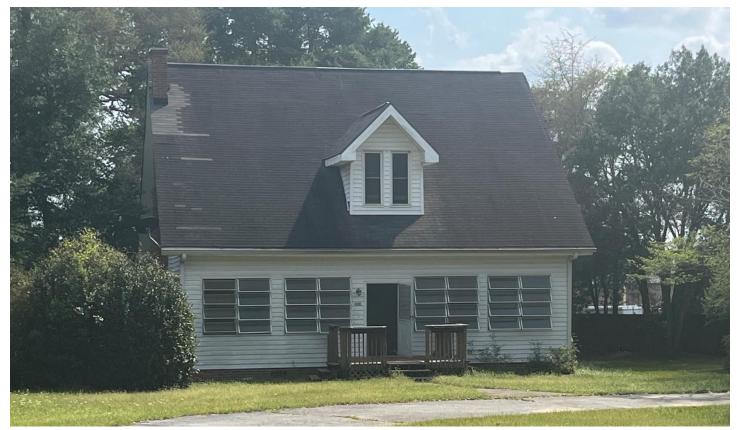
- 1. Edward L. Felder House
- 2. 1870
- 3. –
- 4. Craftsman
- 5. Contributes to neighborhood development pattern.
- 6. Front porch enclosed, roof pitch increased, dormer added.

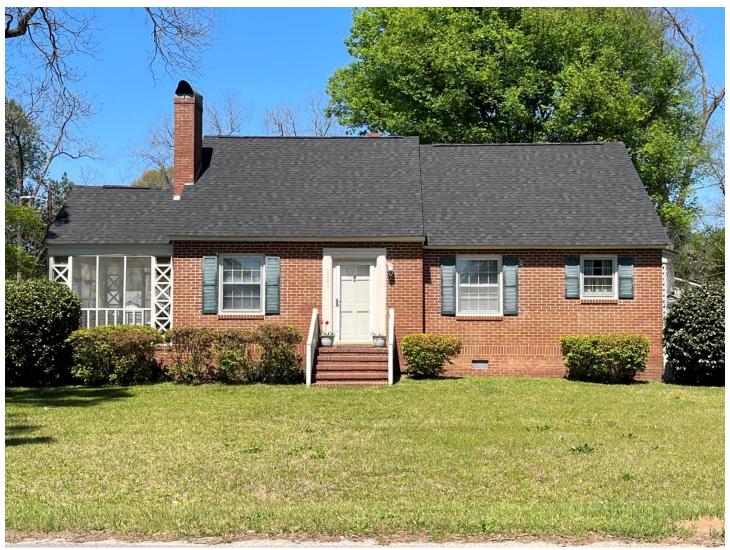
- 1. Mosteller House
- 2. 1948
- 3. -
- 4. Colonial Revival
- 5. Original exterior materials, represents post-WWII era development of Duncan Avenue.
- 6. Detached carport.

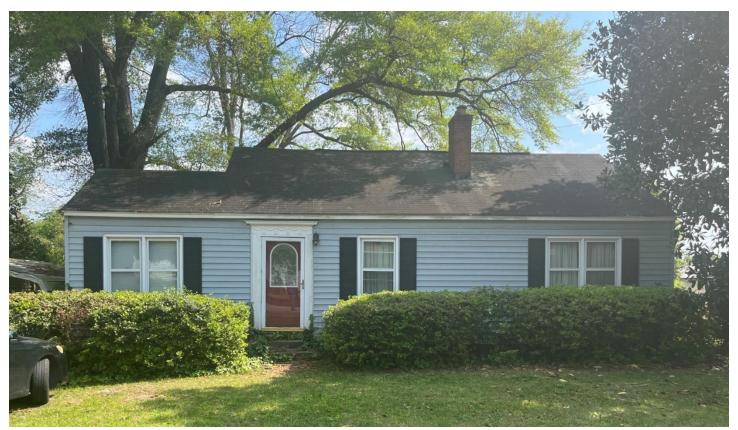
- 1. Unknown
- 2. 1944
- 3. –
- 4. Minimal Traditional
- 5. Represents post-WWII era development of Duncan Avenue.
- 6. Vinyl siding, replacement windows, enclosed side porch.

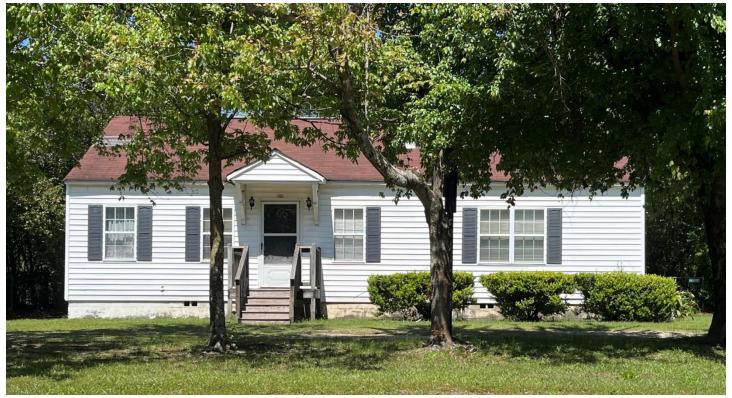
- 1. Unknown
- 2. 1946
- 3. –
- 4. Minimal Traditional
- 5. Represents post-WWII era development of Duncan Avenue.
- 6. Vinyl siding, replacement windows, wood front porch deck, detached carport.

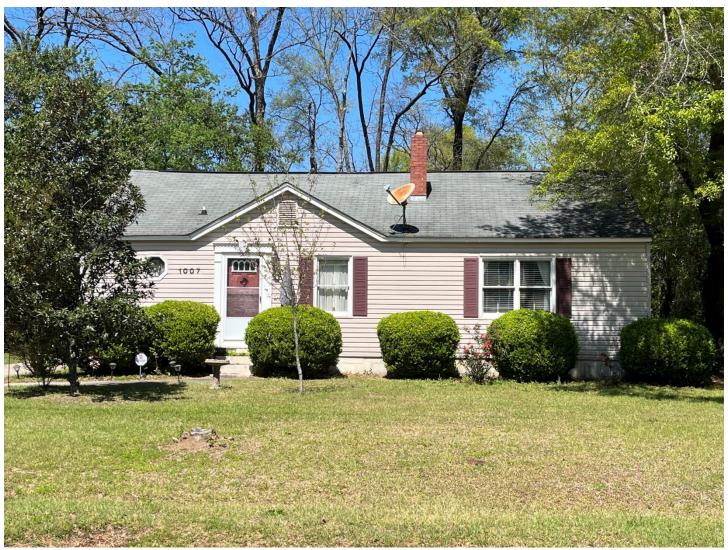
- 1. Unknown
- 2. 1943
- 3. –
- 4. Minimal Traditional
- 5. Represents post-WWII era development of Duncan Avenue.
- 6. Vinyl siding, replacement windows, enclosed side porch, rear addition.

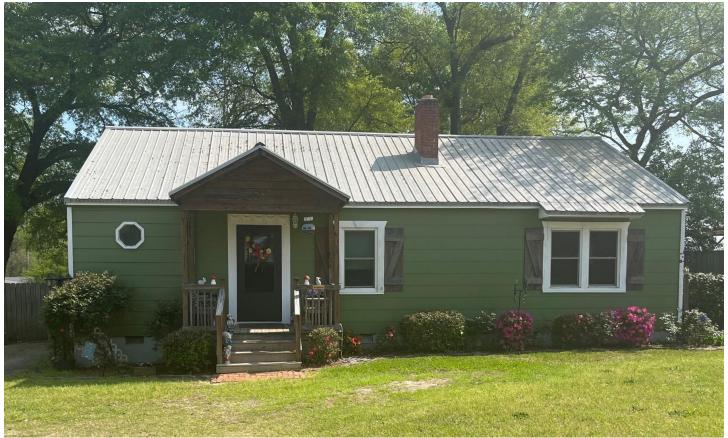
- 1. Unknown
- 2. 11946
- 3. -
- 4. Minimal Traditional
- 5. Represents post-WWII era development of Duncan Avenue.
- 6. Vinyl siding, replacement windows.

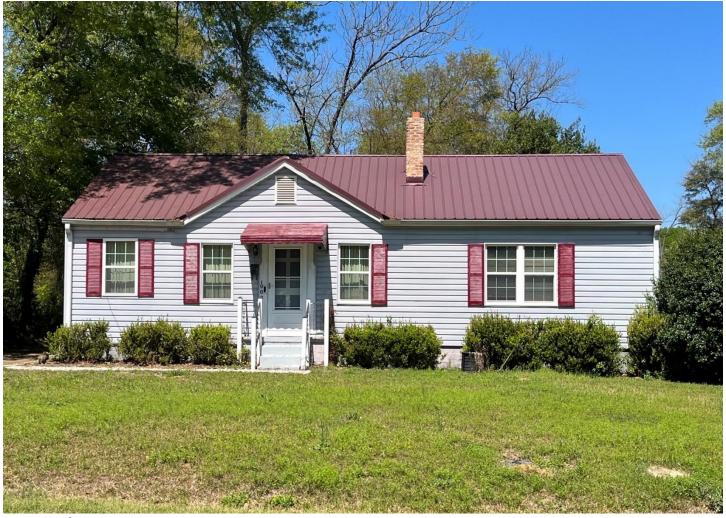
- 1. Unknown
- 2. 1943
- 3. –
- 4. Minimal Traditional
- 5. Original siding, represents post-WWII era development of Duncan Avenue.
- 6. Replacement windows, front porch deck/roof addition.

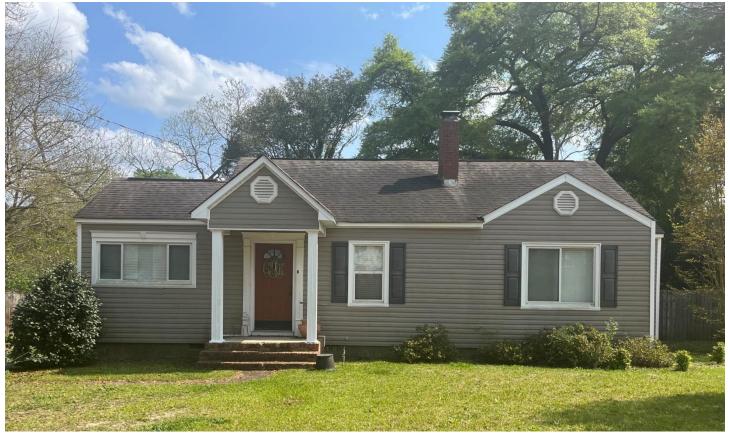
- 1. Unknown
- 2. 1943
- 3. –
- 4. Minimal Traditional
- 5. Represents post-WWII era development of Duncan Avenue.
- 6. Vinyl siding, replacement windows, metal roof, aluminum awning, detached carport.

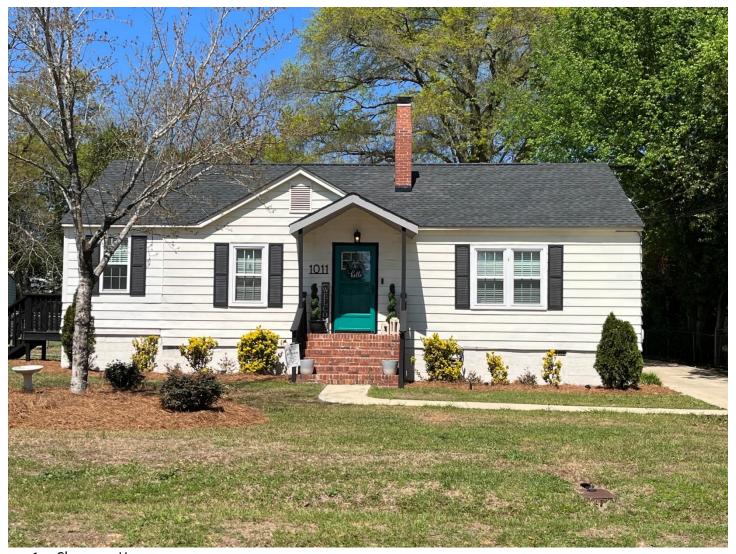
- 1. Unknown
- 2. 1943
- 3. –
- 4. Minimal Traditional
- 5. Represents post-WWII era development of Duncan Avenue.
- 6. Vinyl siding, replacement windows, enclosed side porch, detached outbuilding.

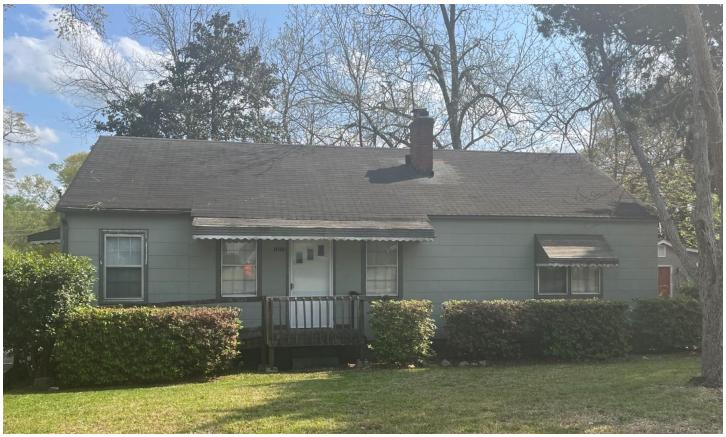
- 1. Chapman House
- 2. 1946
- 3. -
- 4. Minimal Traditional
- 5. Represents post-WWII era development of Duncan Avenue.
- 6. Vinyl siding, replacement windows, enclosed side porch, front porch addition, attached rear carport.

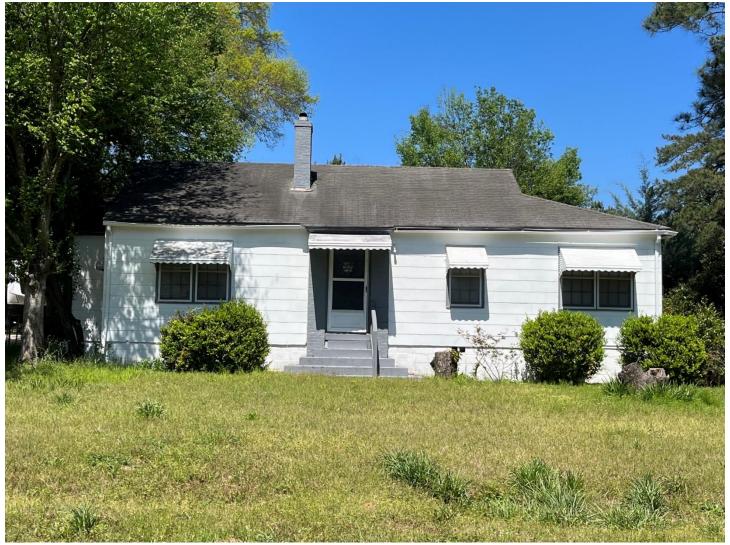
- 1. Unknown
- 2. 1943
- 3. –
- 4. Minimal Traditional
- 5. Original siding and windows, represents post-WWII era development of Duncan Avenue.
- 6. Aluminum awnings, wood front deck and ramp, 3 detached outbuildings.

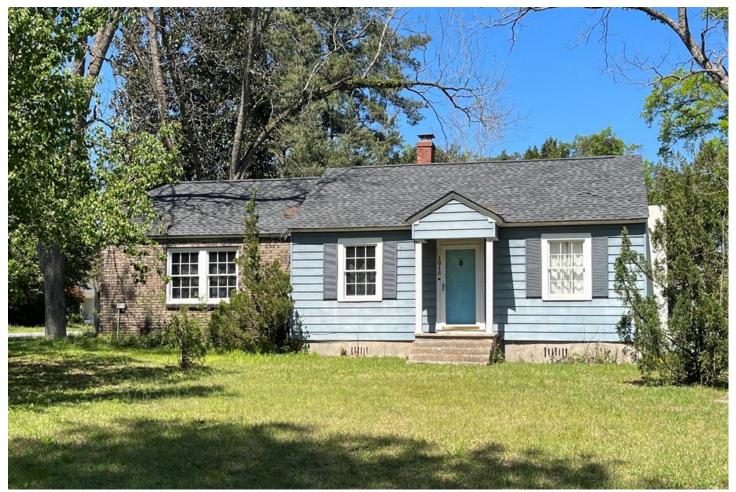
- 1. Brooks House
- 2. 1945
- 3.
- 4. Minimal Traditional
- 5. Original siding and windows, represents post-WWII era development of Duncan Avenue.
- 6. Enclosed side porch, aluminum awning, detached carport.

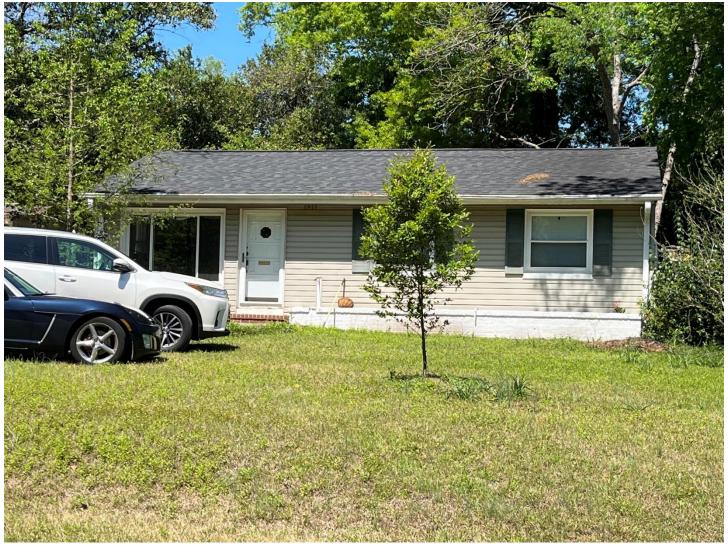
- 1. Unknown
- 2. 1930
- 3. –
- 4. Minimal Traditional
- 5. Represents post-WWII era development of Duncan Avenue.
- 6. Vinyl siding, replacement windows, left side and rear additions, detached carport.

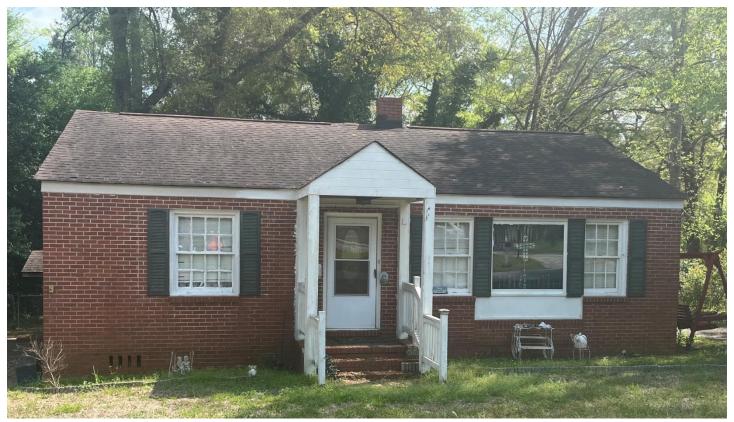
- 1. Johnson House
- 2. 1963
- 3. -
- 4. Minimal Traditional
- 5. Contributes to neighborhood development pattern.
- 6. Vinyl siding, replacement windows, detached outbuilding.

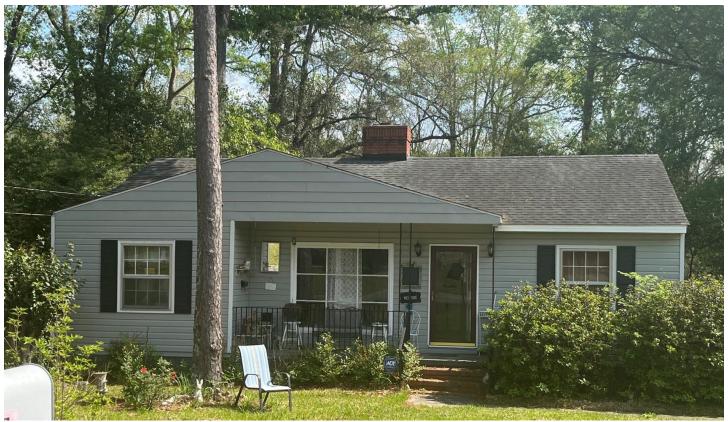
- 1. Chitty House
- 2. 1951
- 3. –
- 4. Minimal Traditional
- 5. Original exterior materials, represents post-WWII era development of Duncan Avenue.
- 6. Rear addition, detached outbuilding.
