Historic Preservation Commission Agenda

LOCAL HISTORIC PROPERTY DESIGNATION REPORT

Washington-Evergreen Historic District

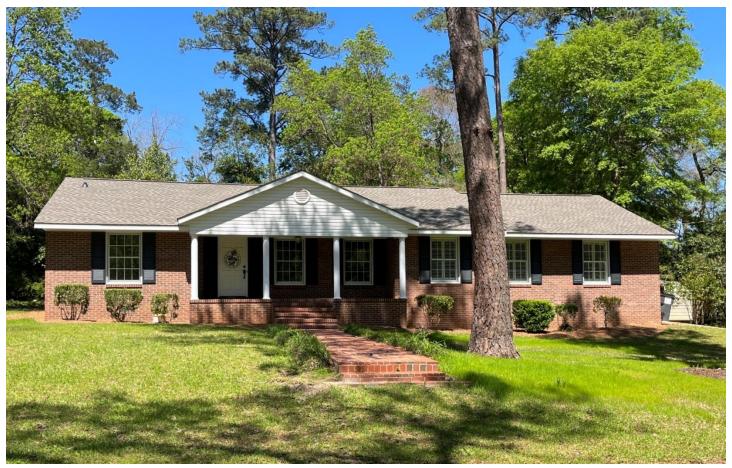
- 1. Lasseter House
- 2. 1950
- 3. –
- 4. No Academic Style
- 5. Original windows, contributes to neighborhood development pattern.
- 6. Vinyl siding.

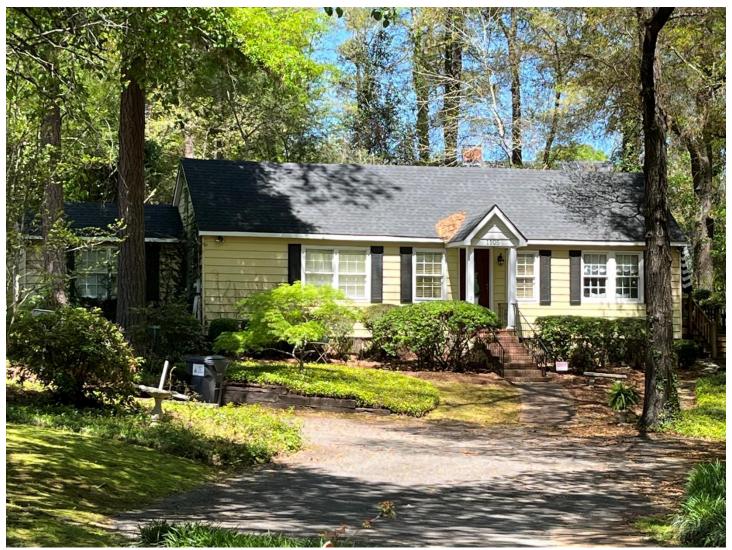
- 1. Pierce House
- 2. 1964
- 3. –
- 4. Minimal Traditional
- 5. Contributes to neighborhood development pattern.
- 6. Vinyl siding on gables, replacement windows, enclosed side carport, 3 detached outbuildings.

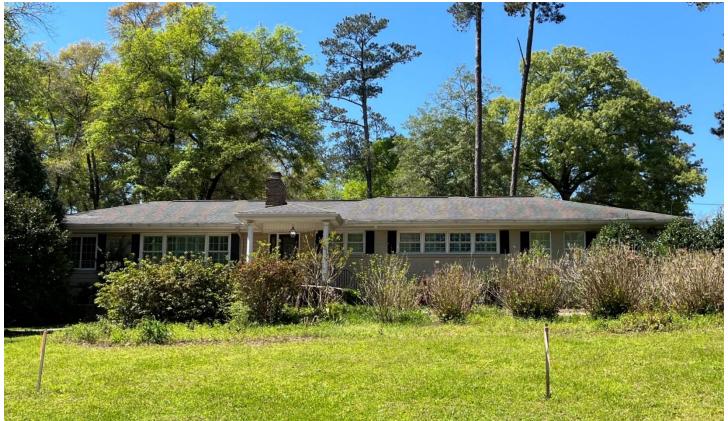
707 Massee Lane 0P0030 092000

- 1. Pierce House
- 2. 1950
- 3.
- 4. Minimal Traditional
- 5. Contributes to neighborhood development pattern.
- 6. Vinyl siding, replacement windows, left side addition.

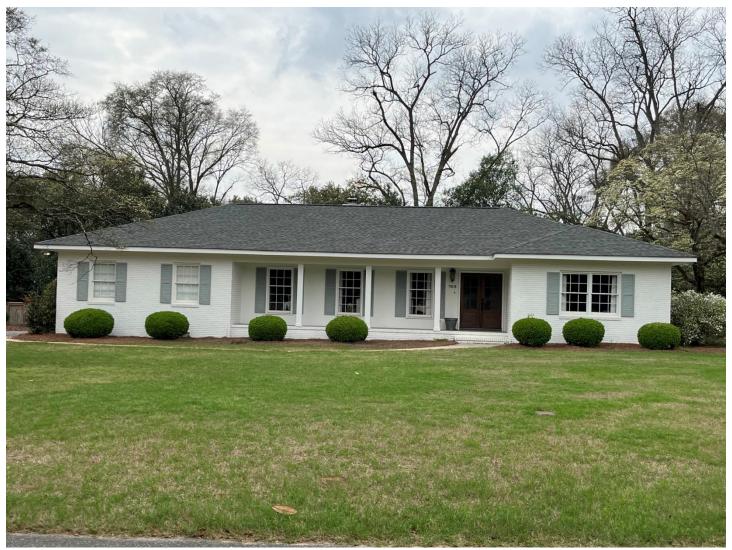
- 1. Watson House
- 2. 1951
- 3. –
- 4. Minimal Traditional
- 5. Contributes to neighborhood development pattern.
- 6. Replacement windows.

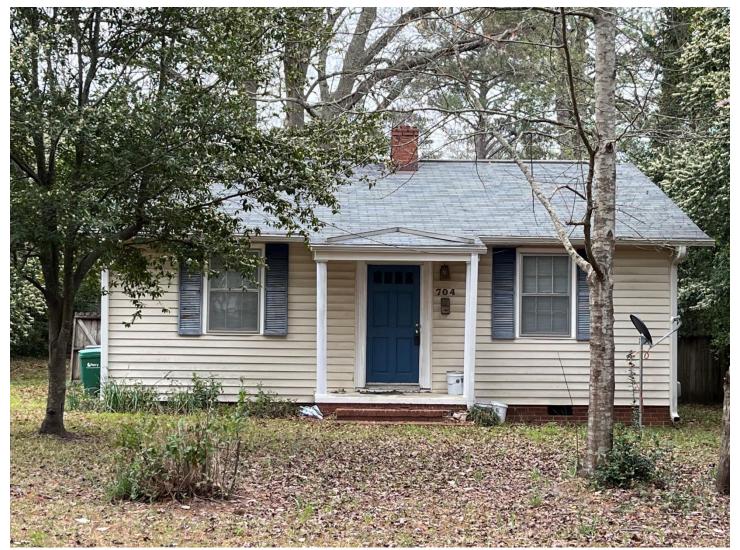
- 1. Medlock House
- 2. 1968
- 3. –
- 4. Minimal Traditional
- 5. Original exterior form, contributes to neighborhood development pattern.
- 6. Painted brick.

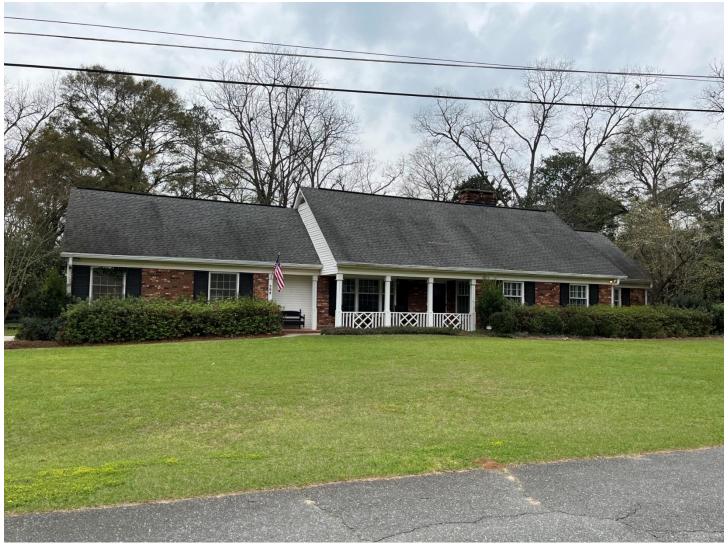
705 Tolleson Avenue 0P0030 033000

- 1. Unknown
- 2. 1947
- 3. -
- 4. Minimal Traditional
- 5. Original windows, represents post-WWII era development of Duncan Avenue area.
- 6. Vinyl siding.

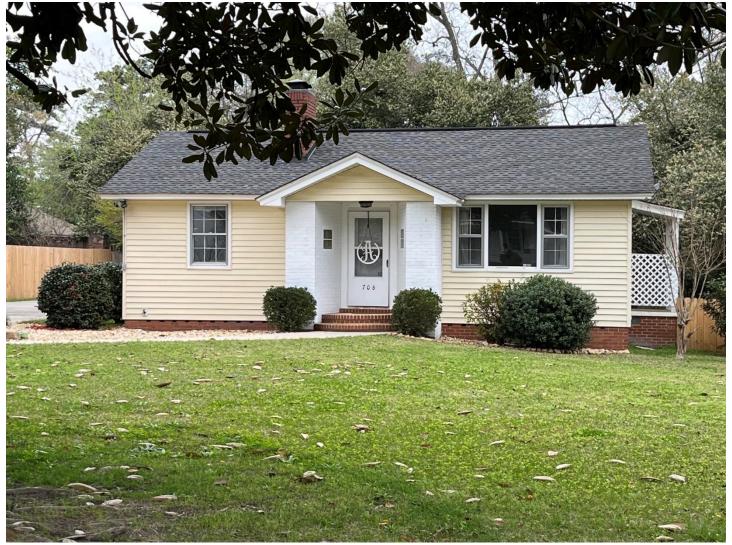
- 1. Weems House
- 2. 1958
- 3. –
- 4. Minimal Traditional
- 5. Original building form, contributes to neighborhood development pattern.
- 6. Replacement windows, vinyl siding on gables, original attached carport enclosed as garage, detached outbuilding.

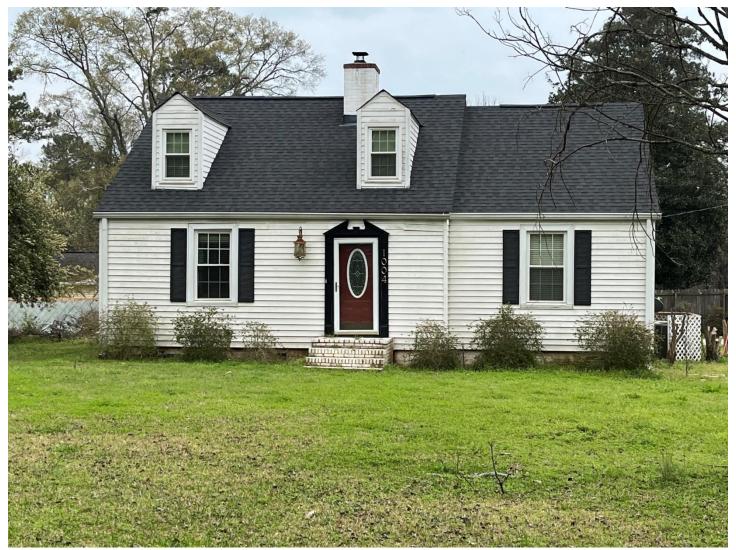
- 1. Unknown
- 2. 1946
- 3. –
- 4. Minimal Traditional
- 5. Original windows, represents post-WWII era development of Duncan Avenue area.
- 6. Vinyl siding, rear addition.

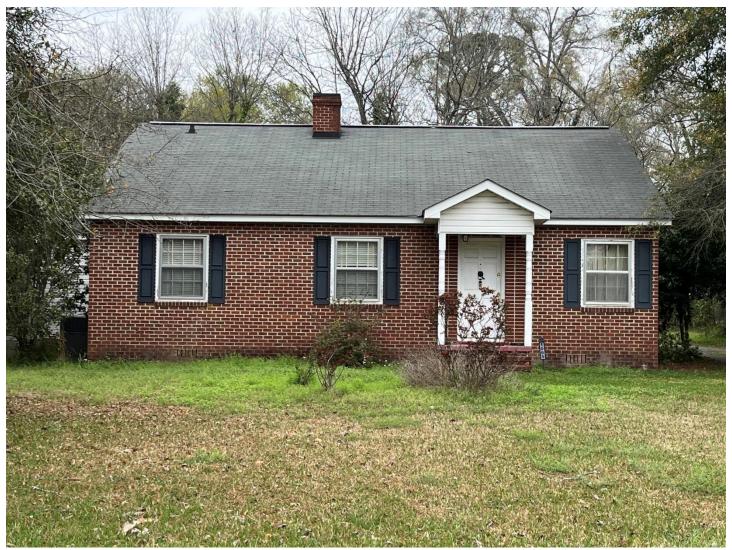
- 1. Unknown
- 2. 1940
- 3.
- 4. Colonial Revival
- 5. Contributes to neighborhood development pattern.
- 6. Vinyl siding, replacement windows, detached outbuilding.

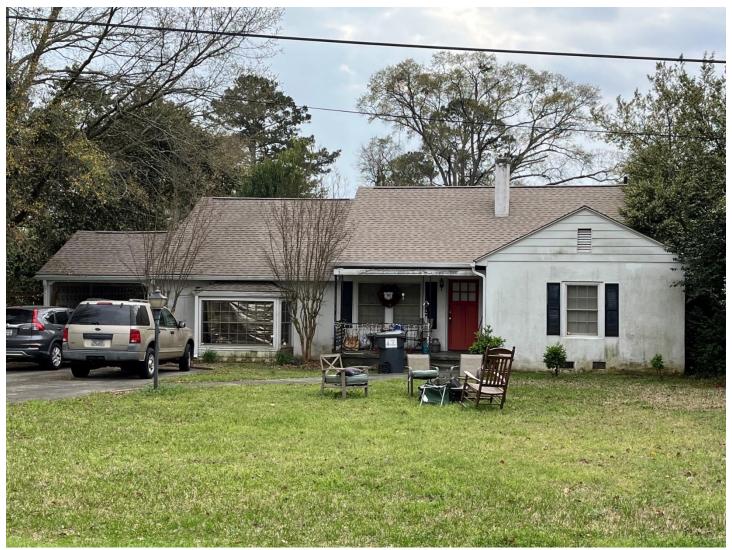
- 1. Rogers House
- 2. 1947
- 3.
- 4. Minimal Traditional
- 5. Original exterior materials, represents post-WWII era development of Duncan Avenue area.
- 6. Vinyl shutters, siding on porch gable, right side addition, detached outbuilding.

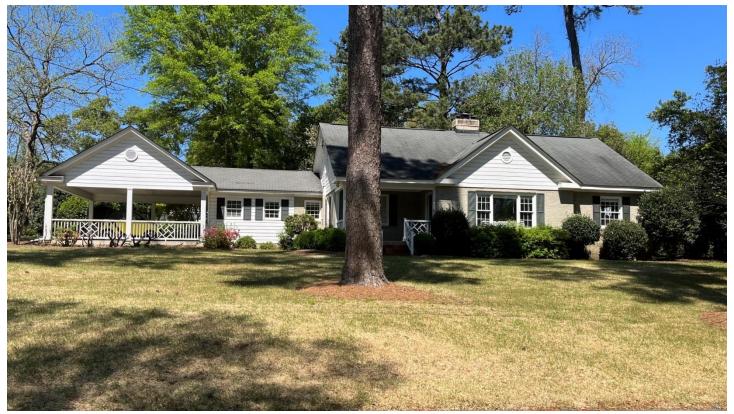
- 1. Rape House
- 2. 1946
- 3. –
- 4. Minimal Traditional
- 5. Represents post WWII era development of Duncan Avenue area.
- 6. Side addition, attached carport, replacement windows, aluminum siding on gable ends, aluminum porch cover.

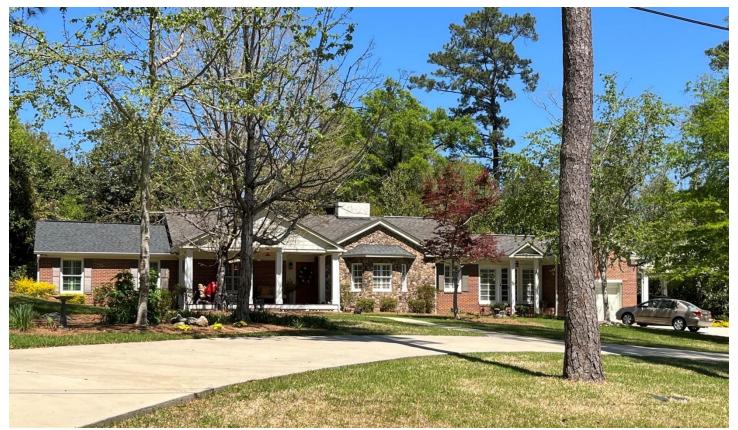
- 1. Unknown
- 2. 1947
- 3. –
- 4. Neoclassical Revival
- 5. Contributes to neighborhood development pattern.
- 6. Vinyl siding, replacement windows, right side wing addition, deck.

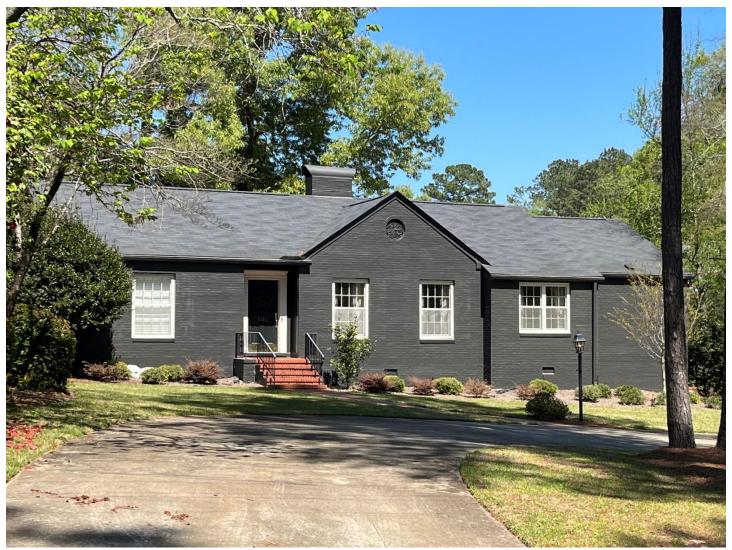
- 1. Unknown
- 2. 1949
- 3. Renovations, additions 2020
- 4. Minimal Traditional
- 5. Contributes to neighborhood development pattern.
- 6. Left side addition, stone veneer, attached carport.

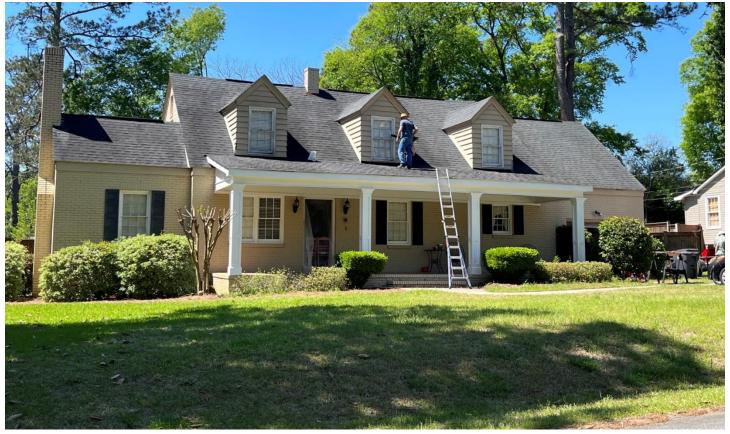
- 1. Grant House
- 2. 1952
- 3.
- 4. Minimal Traditional
- 5. Contributes to neighborhood development pattern.
- 6. Painted brick, replacement windows, right side and rear addition.

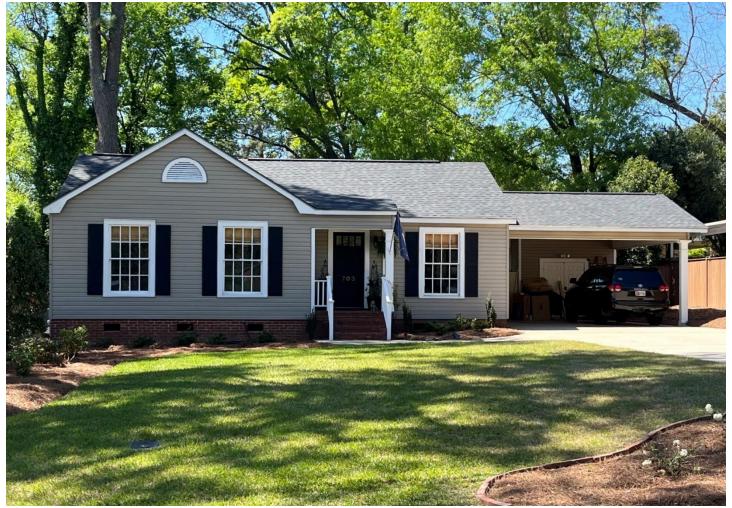
- 1. Bozeman House
- 2. 1955
- 3. –
- 4. Colonial Revival
- 5. Original exterior materials, contributes to neighborhood development pattern.
- 6. None

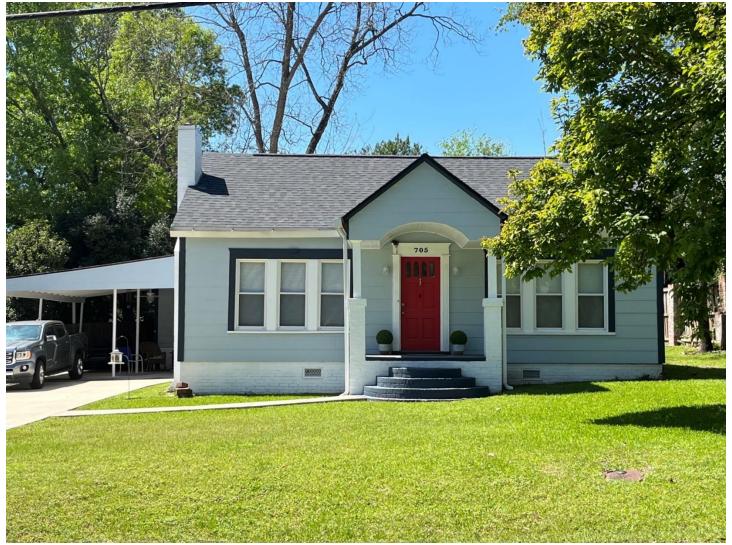
- 1. Whipple House
- 2. 1951
- 3. –
- 4. No Academic Style
- 5. Original exterior materials, contributes to neighborhood development pattern.
- 6. Detached carport in front yard.

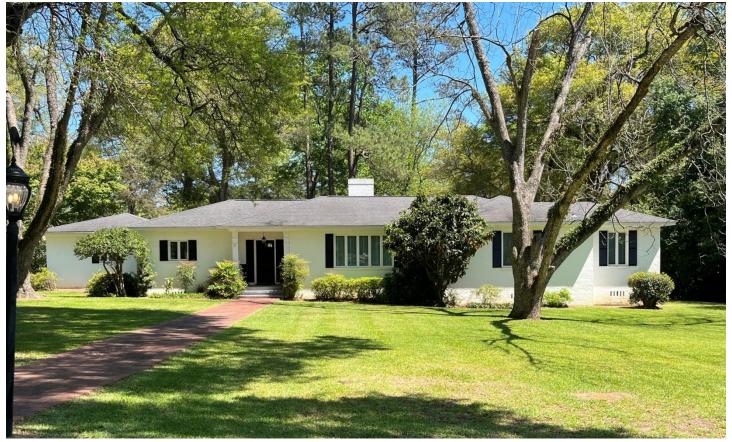
- 1. Unknown
- 2. 1939
- 3. –
- 4. Colonial Revival
- 5. Contributes to neighborhood development pattern.
- 6. Replacement windows, cementitious siding, attached carport addition.

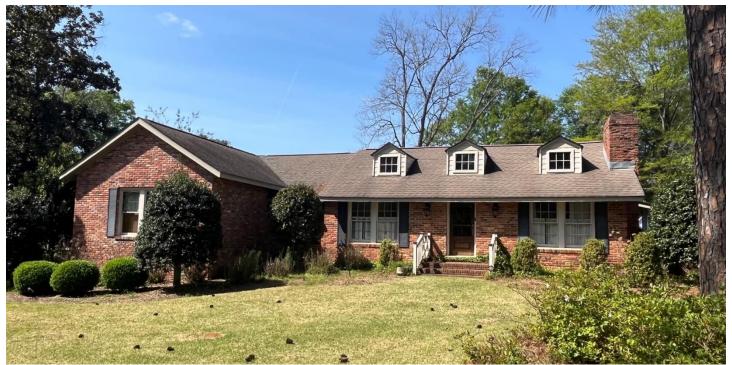
- 1. Brown House
- 2. 1948
- 3. –
- 4. Minimal Traditional
- 5. Original form, contributes to neighborhood development pattern.
- 6. Replacement windows, detached outbuilding.

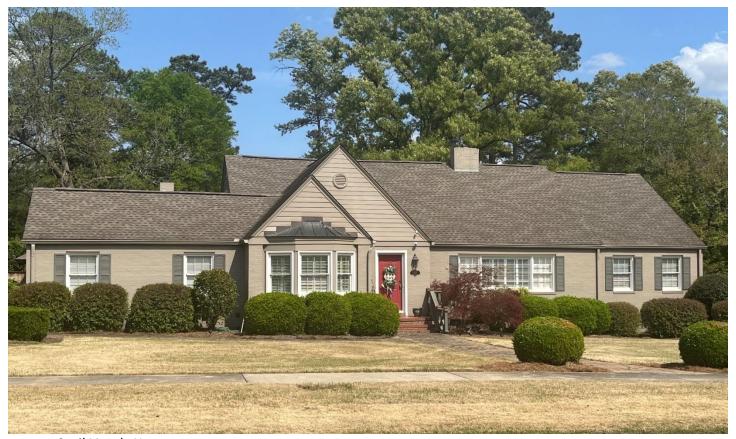
- 1. Unknown
- 2. 1941
- 3. –
- 4. Minimal Traditional
- 5. Contributes to neighborhood development pattern.
- 6. Multiple additions

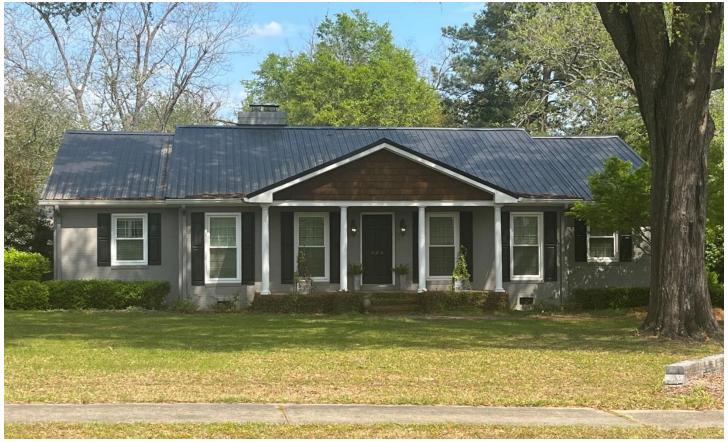
- 1. Cecil Moody House
- 2. 1951
- 3. –
- 4. English Vernacular Revival/Minimal Traditional
- 5. Original form, contributes to neighborhood development pattern.
- 6. Replacement windows, detached garage constructed in 2009.

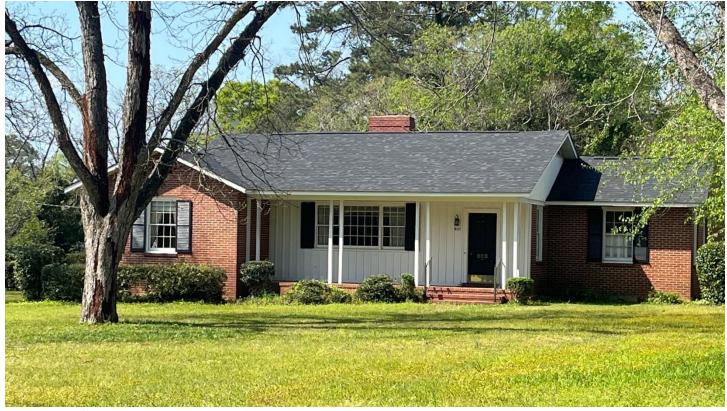
- 1. Allen Pritchett House
- 2. 1961
- 3. –
- 4. Minimal Traditional
- 5. Original form, contributes to neighborhood development pattern
- 6. Painted brick, replacement windows, vinyl shingles on gables, metal roof, rear addition, detached outbuilding.

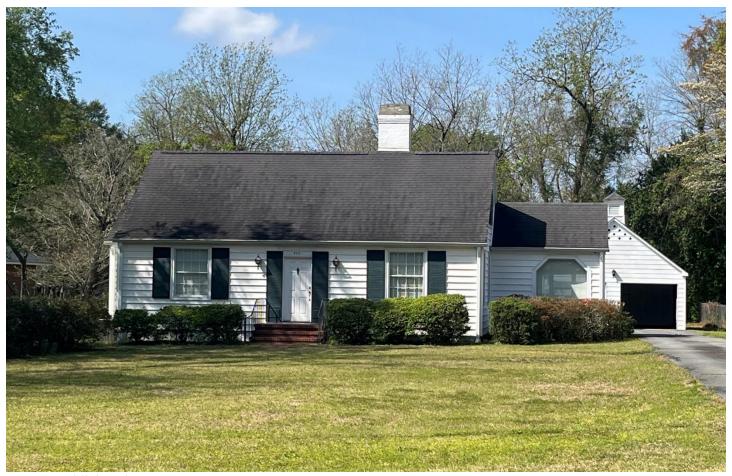
- 1. Coralie Brown Nunn House
- 2. 1951
- 3. –
- 4. Minimal Traditional
- 5. Original exterior materials, contributes to neighborhood development pattern.
- 6. Replacement windows, rear addition and attached carport.

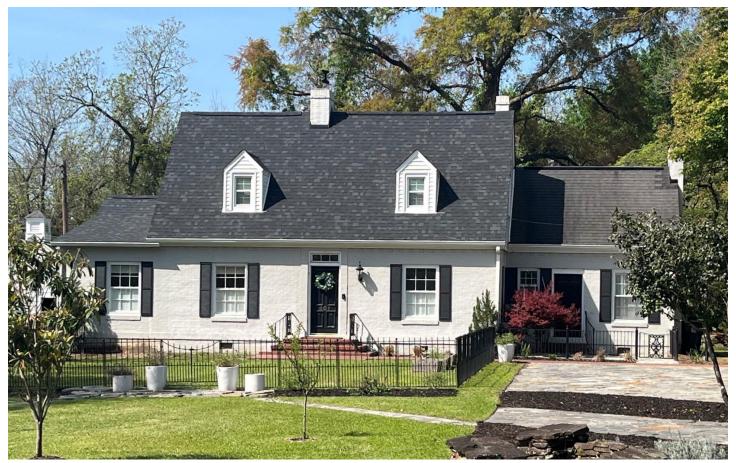
- 1. Middlebrooks House
- 2. 1942
- 3. –
- 4. Colonial Revival
- 5. Original windows, contributes to neighborhood development pattern.
- 6. Vinyl siding, enclosed side porch, detached garage 1978.

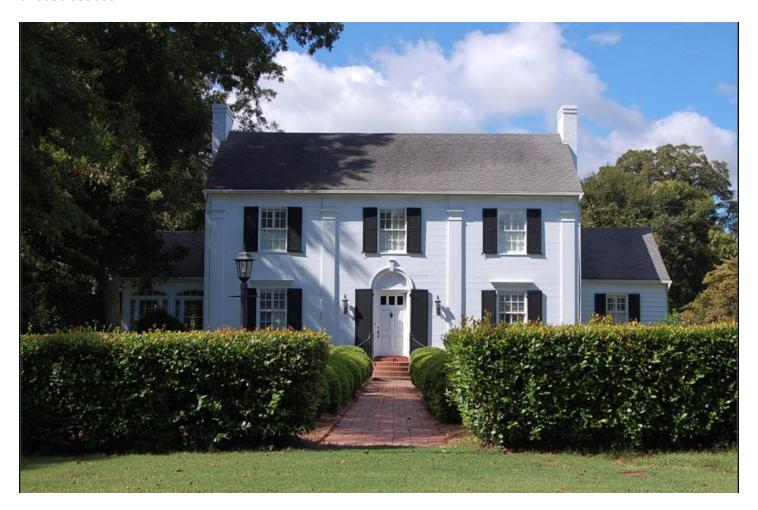
- 1. Mrs. F. M. Houser House
- 2. 1940
- 3. –
- 4. Colonial Revival
- 5. Contributes to neighborhood development pattern.
- 6. Replacement windows, right side, left side, rear additions, painted brick.

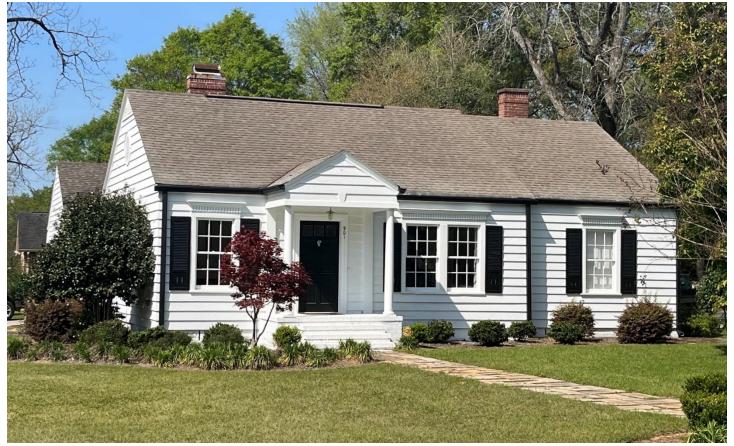
- 1. Davis-Sexton House
- 2. 1939
- 3. –
- 4. Colonial Revival
- 5. Original exterior materials, contributes to neighborhood development pattern.
- 6. Rear addition

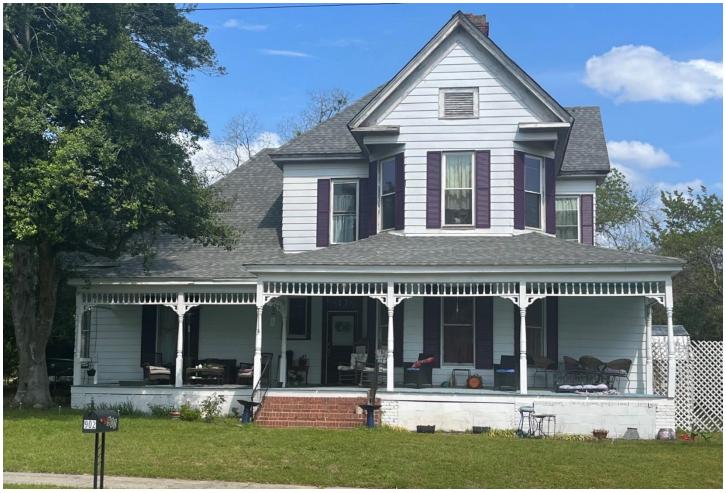
- 1. John Hodges House
- 2. 1941
- 3. –
- 4. Colonial Revival
- 5. Original exterior materials, contributes to neighborhood development pattern.
- 6. Rear addition, detached carport added 2017.

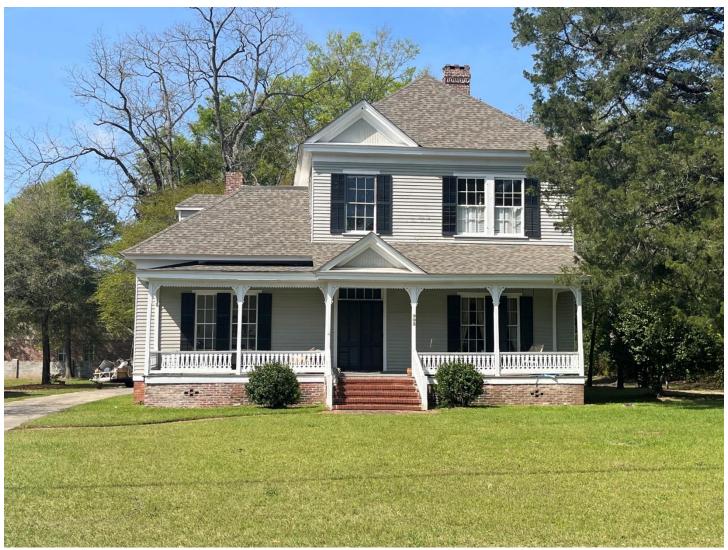
- 1. John Hicks Hodges House
- 2. 1894
- 3. Home of General Courtney Hodges, commander of the First United States Army during World War II
- 4. American Queen Anne
- 5. Original exterior siding, windows, details, contributes to neighborhood development pattern.
- 6. Detached utility building constructed in 1976.

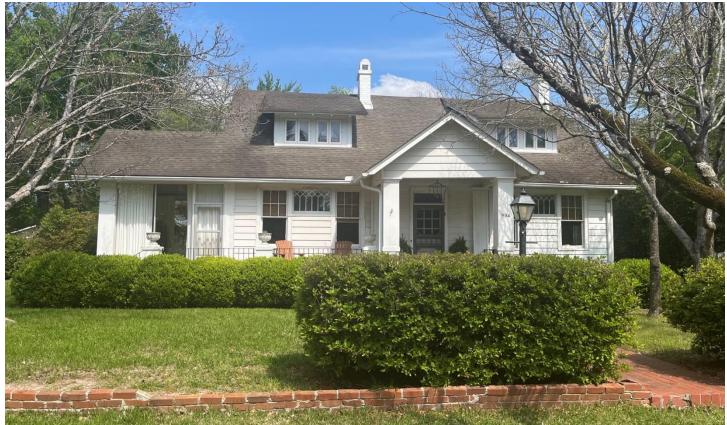
- 1. Mrs. Jule Hurst House
- 2. 1913
- 3. –
- 4. Craftsman
- 5. Original first floor windows, contributes to neighborhood development pattern.
- 6. Vinyl siding, replacement dormer windows, enclosed side porch, rear addition.

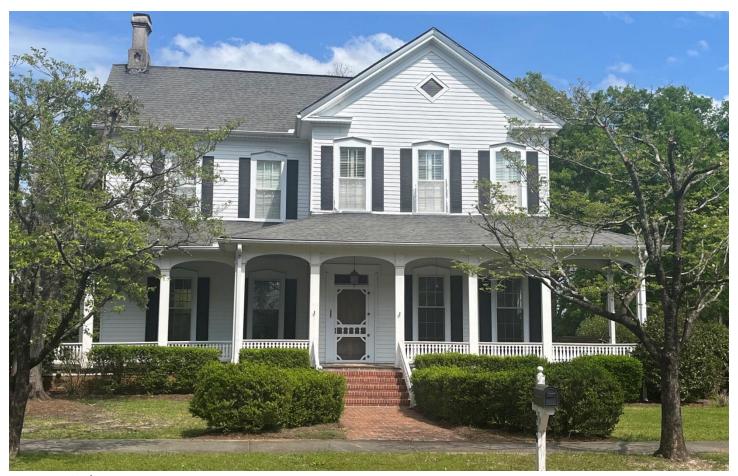
- 1. Pringle House
- 2. 1880
- 3. –
- 4. Folk Victorian
- 5. Original siding and details, contributes to neighborhood development pattern.
- 6. Replacement windows, rear addition, detached carport 1992.

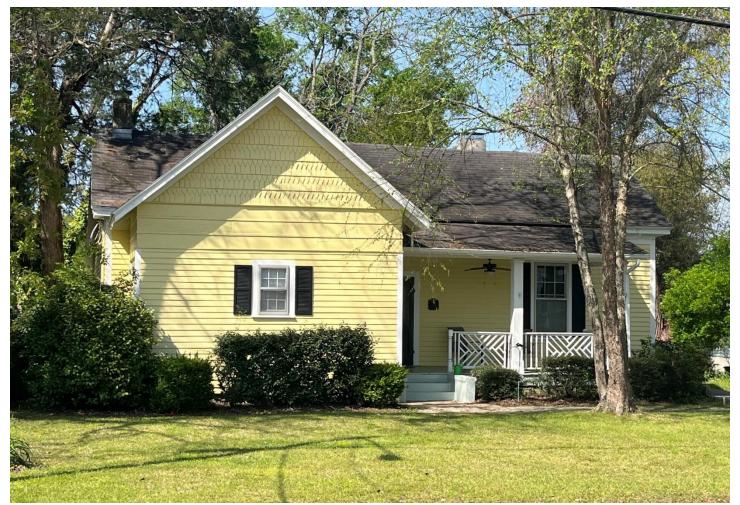
- 1. Anderson House
- 2. c. 1900
- 3. –
- 4. Folk Victorian
- 5. Original siding, contributes to neighborhood development pattern.
- 6. Front ell altered, some replacement wood siding, altered window size, detached carport.

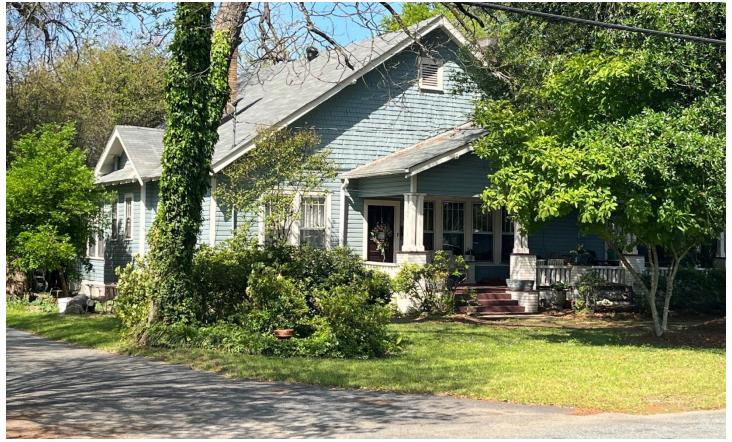
- 1. James M. Gooden House
- 2. 1926
- 3. –
- 4. Craftsman
- 5. Original siding and windows, contributes to neighborhood development pattern.
- 6. None

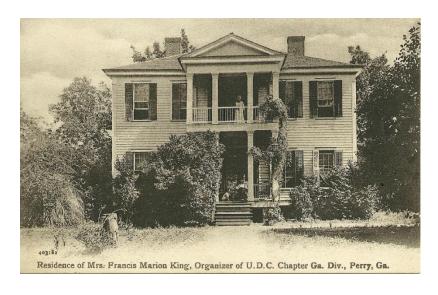
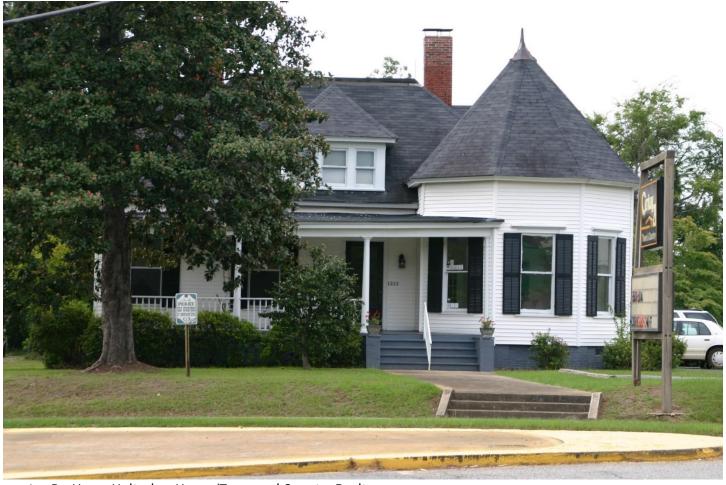
- 1. Samuel D. Killen House/Watson Hunt Mortuary
- 2. 1852
- 3. In the 1920s the house was used as a clubhouse for visiting officials of the Pennsylvania Dixie Cement Corporation. Purchased for use as a mortuary in 1955, its current use. Modification of the front porch and the side wing additions likely occurred around 1955.
- 4. Greek Revival/Neoclassical Revival
- 5. Prominent structure on Main Street, contributes to neighborhood development pattern.
- 6. Front porch altered, wings added and expanded, garage added in 1983.

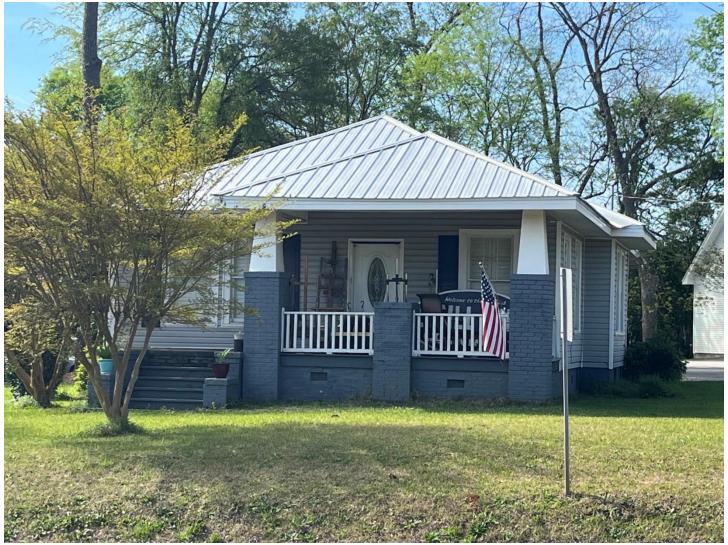
- 1. Penn Dixie Worker House
- 2. 1925
- 3. Sears, Roebuck & Co. kit house, assembled by local carpenter Willie Bell Roberts
- 4. Craftsman
- 5. Original form, represents workforce housing needs for local industry.
- 6. Vinyl siding, replacement windows, front door, enclosed eaves, metal roof.

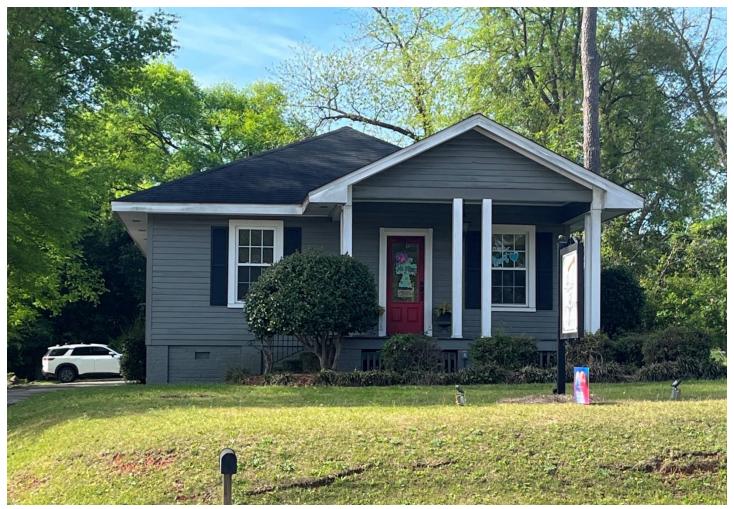
- 1. Penn Dixie Worker House/Salon Seven
- 2. 1925
- 3. Sears, Roebuck & Co. kit house, assembled by local carpenter Willie Bell Roberts. Now used as a salon.
- 4. Craftsman
- 5. Original siding, front door, represents workforce housing needs for local industry.
- 6. Replacement windows, porch columns, enclosed eaves, rear parking.

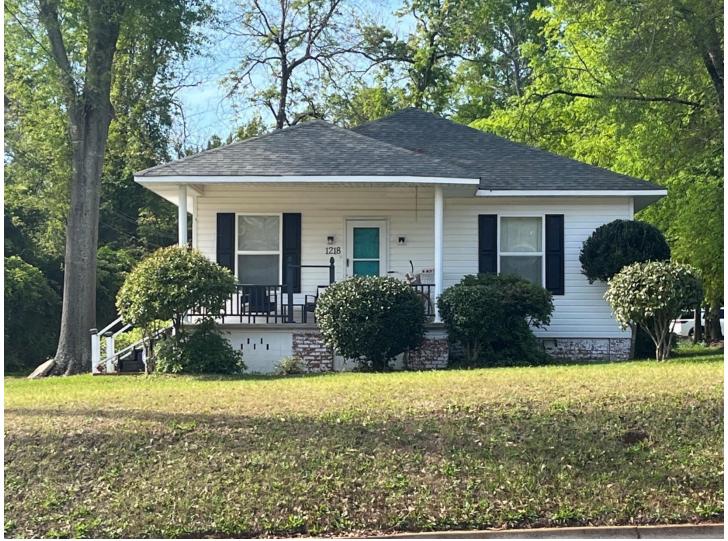
- 1. Penn Dixie Worker House
- 2. 1925
- 3. Sears Roebuck & Co. kit house, assembled by local carpenter Willie Bell Roberts.
- 4. Craftsman
- 5. Represents workforce housing needs for local industry.
- 6. Vinyl siding, replacement windows, porch columns, front door, enclosed eaves, rear addition in 2004.

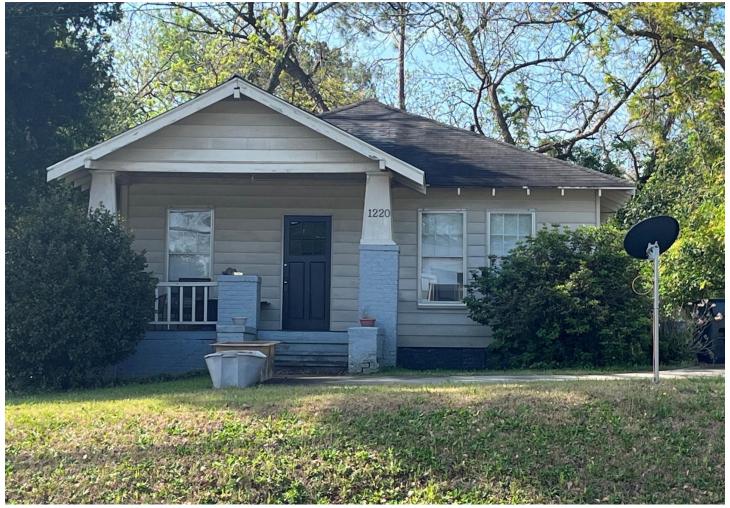
- 1. Penn Dixie Worker House
- 2. 1925
- 3. Sears, Roebuck & Co. kit house, assembled by local carpenter Willie Bell Roberts
- 4. Craftsman
- 5. Original front door, exposed rafter tails, represents workforce housing needs for local industry.
- 6. Aluminum siding, replacement windows.

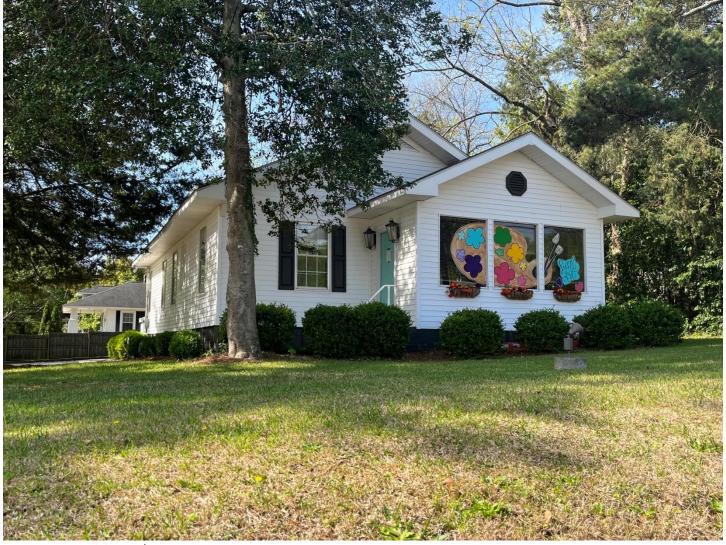
- 1. Penn Dixie Worker House
- 2. 1925
- 3. Sears, Roebuck & Co. kit house, assembled by local carpenter Willie Bell Roberts. Now used as an art studio.
- 4. Craftsman
- 5. Represents workforce housing needs for local industry.
- 6. Vinyl siding, replacement windows, enclosed front porch, enclosed eaves, rear addition, rear parking.

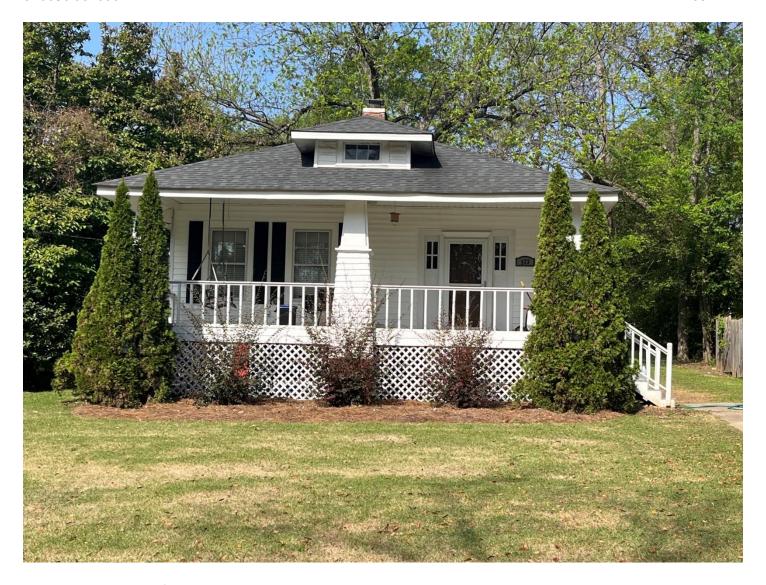
- 1. Penn Dixie Worker House
- 2. 1925
- 3. Sears, Roebuck & Co. kit house, assembled by local carpenter Willie Bell Roberts
- 4. Craftsman
- 5. Original side lights at front door, represents workforce housing needs for local industry.
- 6. Vinyl siding, replacement windows, railing, enclosed side porch, 2 detached outbuildings.

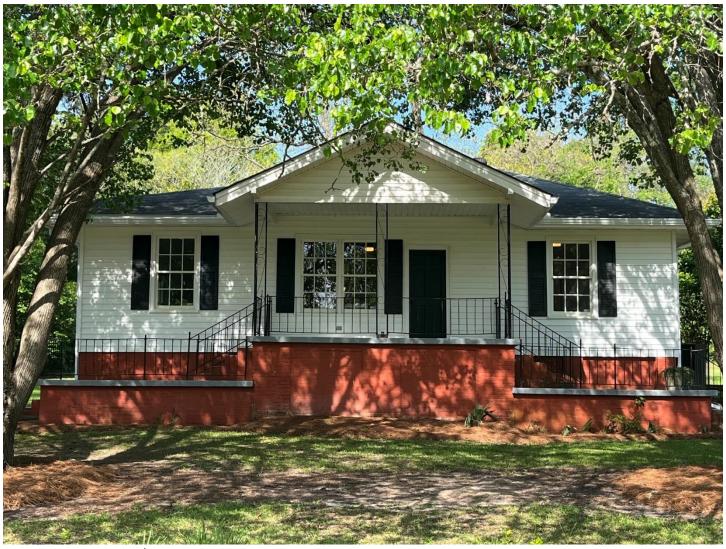
- 1. Penn Dixie Worker House
- 2. 1925
- 3. Sears, Roebuck & Co. kit house, assembled by local carpenter Willie Bell Roberts
- 4. Craftsman
- 5. Original windows, represents workforce housing needs for local industry.
- 6. Left side addition, vinyl siding, wrought iron railing/columns.

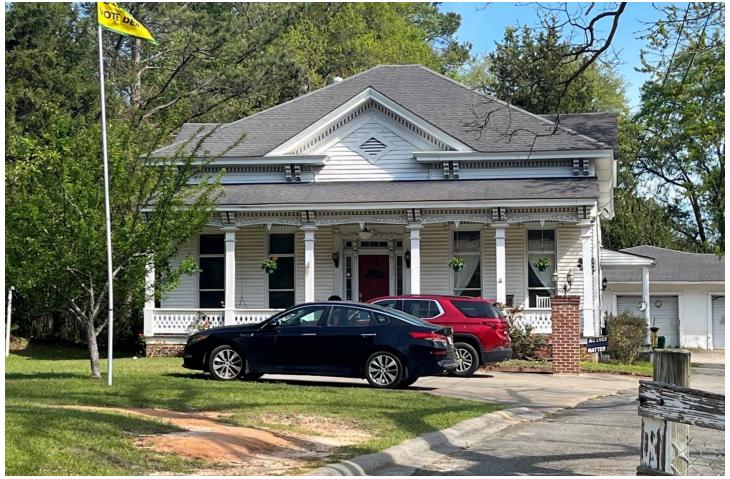
- 1. W. H. Norwood House
- 2. 1874
- 3. Relocated from Main Street to its current location in 1962, only the center portion of the original house was moved, currently used as an office.
- 4. Carpenter Italianate
- 5. Original siding, details
- 6. Replacement windows, detached garage in 1982, addition to rear of house in 2008.

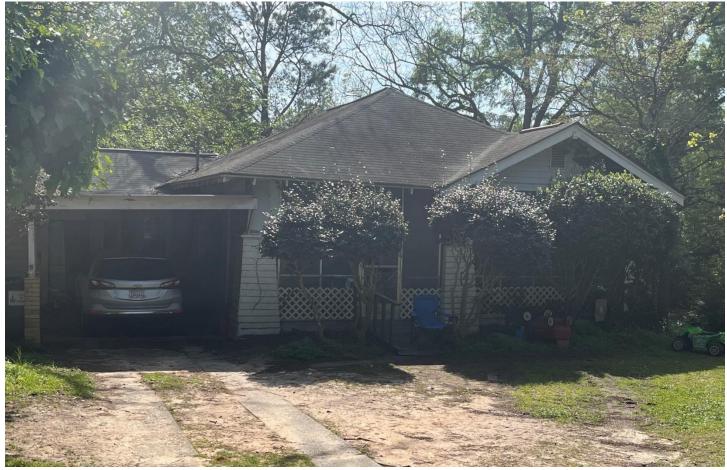
- 1. Penn Dixie Worker House
- 2. 1925
- 3. Sears, Roebuck & Co. kit house, assembled by local carpenter Willie Bell Roberts
- 4. Craftsman
- 5. Exposed rafter tails, original porch piers, represents workforce housing needs for local industry.
- 6. Left side addition and carport.

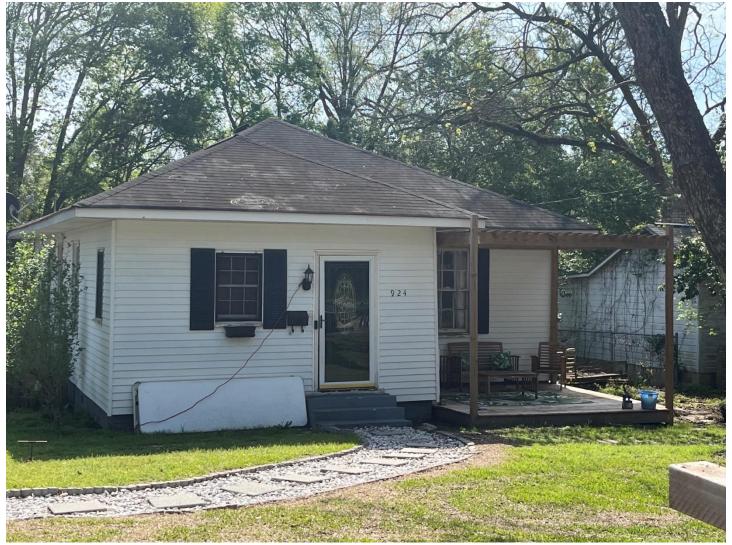
- 1. Penn Dixie Worker House
- 2. 1925
- 3. Sears, Roebuck & Co. kit house, assembled by local carpenter Willie Bell Roberts
- 4. Craftsman
- 5. Original windows, represents workforce housing needs for local industry.
- 6. Front porch enclosed, front deck/arbor, vinyl siding, enclosed eaves, right side addition, detached outbuilding.

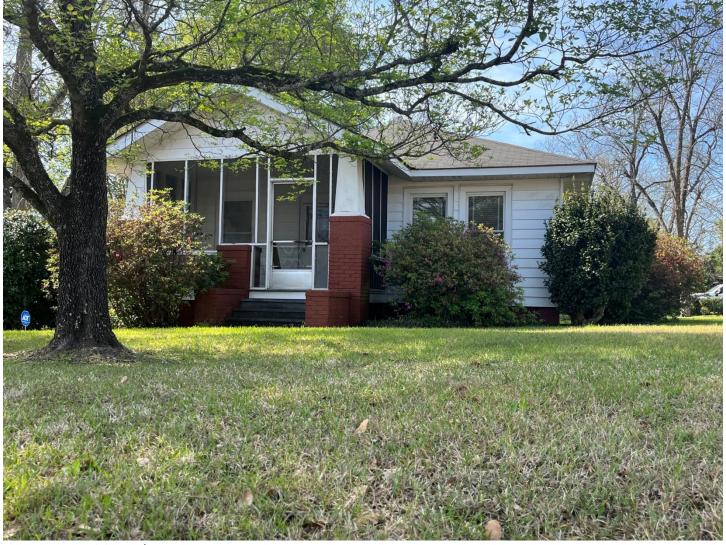
- 1. Penn Dixie Worker House
- 2. 1925
- 3. Sears, Roebuck & Co. kit house, assembled by local carpenter Willie Bell Roberts
- 4. Craftsman
- 5. Original front door, represents workforce housing needs for local industry.
- 6. Aluminum siding, replacement windows, enclosed eaves, screened front porch, detached carport and outbuilding.

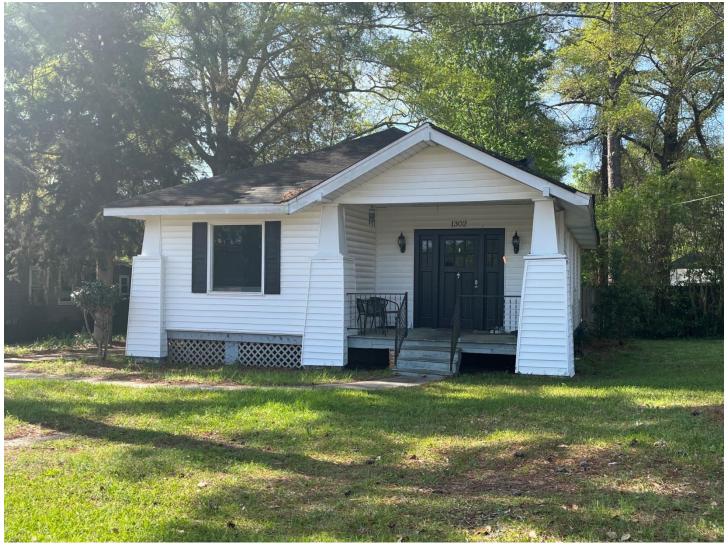
- 1. Penn Dixie Worker House
- 2. 1925
- 3. Sears, Roebuck & Co. kit house, assembled by local carpenter Willie Bell Roberts
- 4. Craftsman
- 5. Original front door and side lights, represents workforce housing needs for local industry.
- 6. Vinyl siding, replacement windows, enclosed eaves, partially enclosed front porch, enclosed side porch, detached outbuilding.

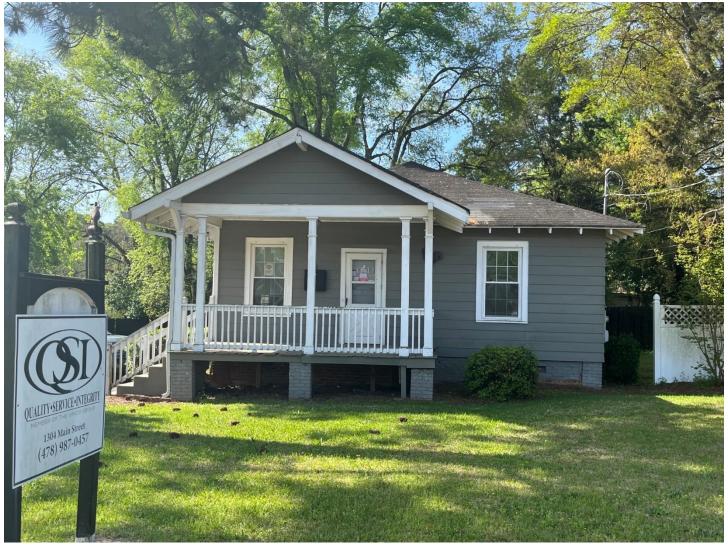
- 1. Penn Dixie Worker House
- 2. 1925
- 3. Sears, Roebuck & Co. kit house, assembled by local carpenter Willie Bell Roberts. Now used for professional offices.
- 4. Craftsman
- 5. Original siding, exposed rafter tails, represents workforce housing needs for local industry.
- 6. Replacement windows and front door, porch columns and railing, rear addition, side parking
